Notice of Intention to Demolish

32 Connaught Cres., Bolton, ON, L7E 2S2
(Lots 38 & 39, Registered Plan C-12, Town of Caledon, Regional Municipality of Peel)

HERITAGE IMPACT STATEMENT

32 Connaught Crescent, Bolton ON
Township of Caledon

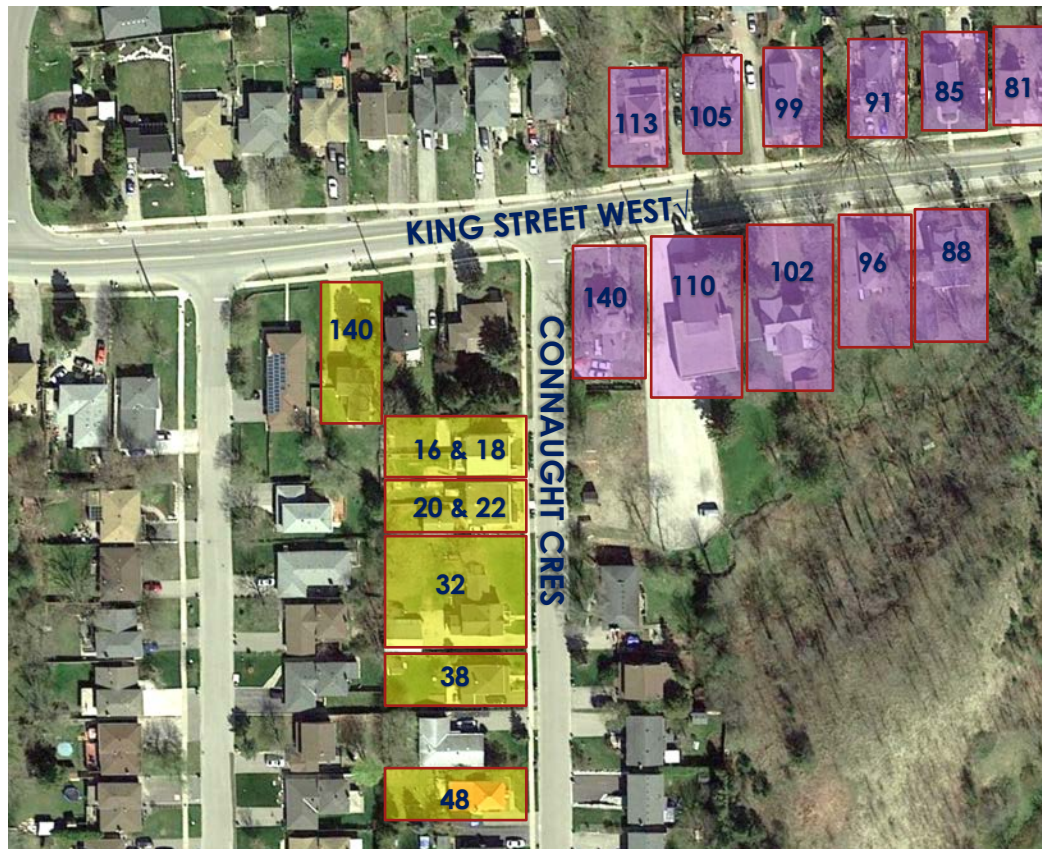
- Properties Designated Under Part V of the *Ontario Heritage Act*
- Non-Designated Properties Listed Under Section 27 (1.2) of the *Ontario Heritage Act*

Figure 11: Illustration identifying designated and listed heritage properties immediately adjacent to the site, 32 Connaught. (Source: Google Earth, Annotated by SVMA).

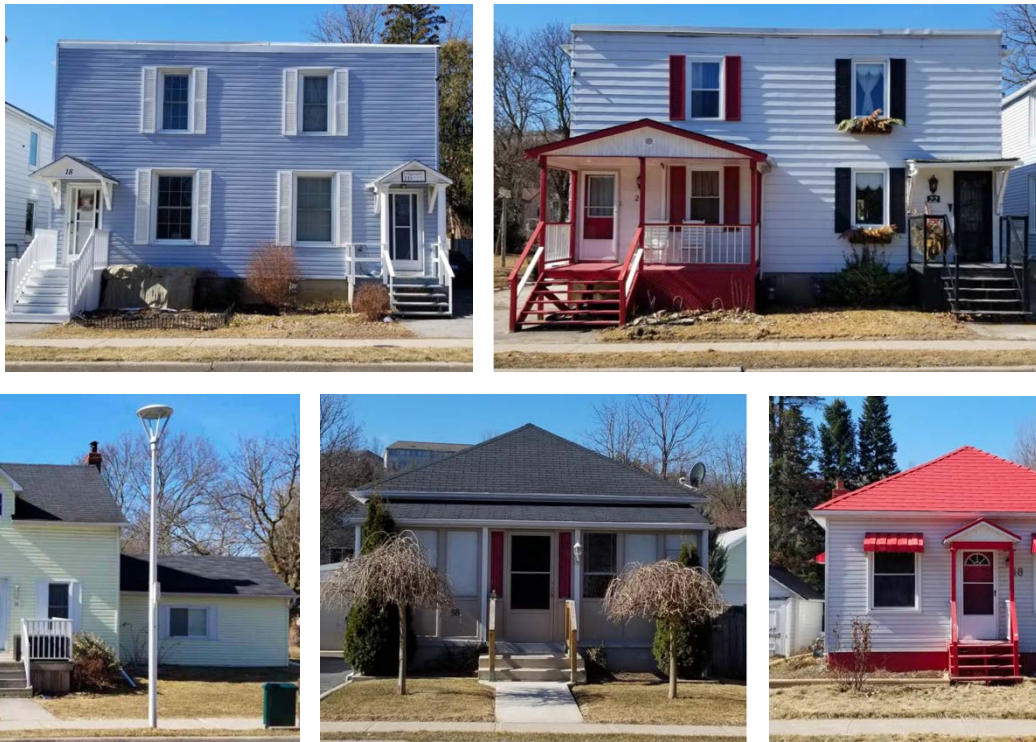
Figure 12: Properties on Connaught Crescent listed on the Town of Caledon's Heritage Register. Starting from top left is: duplex 16 & 18, duplex 22 & 24, single dwellings 32, 38 and 48.

- 38 Connaught Street is a single-storey house, Regency style, hip roof, centre entry, verandah and frame construction. It was built circa 1910 or later.
- 48 Connaught Street is a single-storey house, Regency style, hip roof, centre entry, symmetrical placed windows and framed construction. It was built circa 1910 or later.

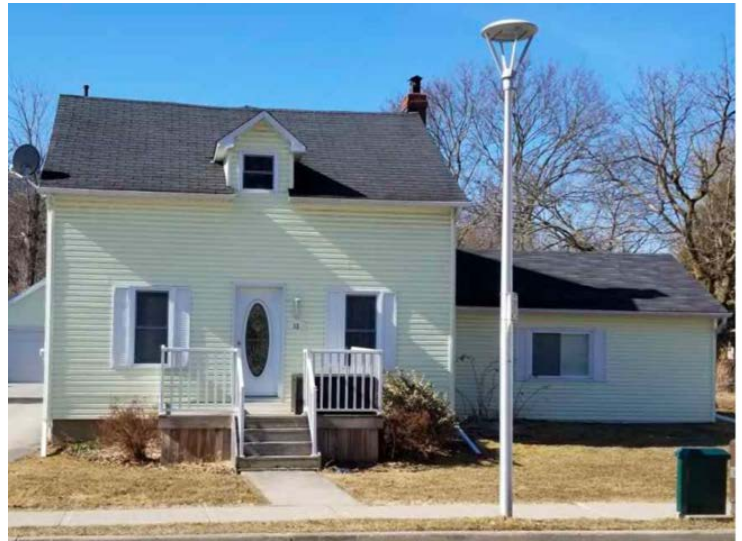
Figure 23: Front (east) elevation of 32 Connaught Crescent.

Section 1 is the original dwelling, noted by the Town of Caledon to be built circa 1910. It was likely built between the years 1912-1931. It is a 1-1/2 storey structure that consists of a stone foundation and frame construction above with a basement. The existing exterior cladding is vinyl.

Section 2 is an addition built between 1954 – 1967. It is a one-storey structure that consists of a concrete block foundation and frame construction above. It is connected to the interior space of the original building. The existing exterior cladding is vinyl.

Section 3, it is unclear when this portion is built, likely after 1967. This part is a one-storey structure that consists of exposed concrete pier foundations and frame construction above. It is connected to the interior space of the original building.

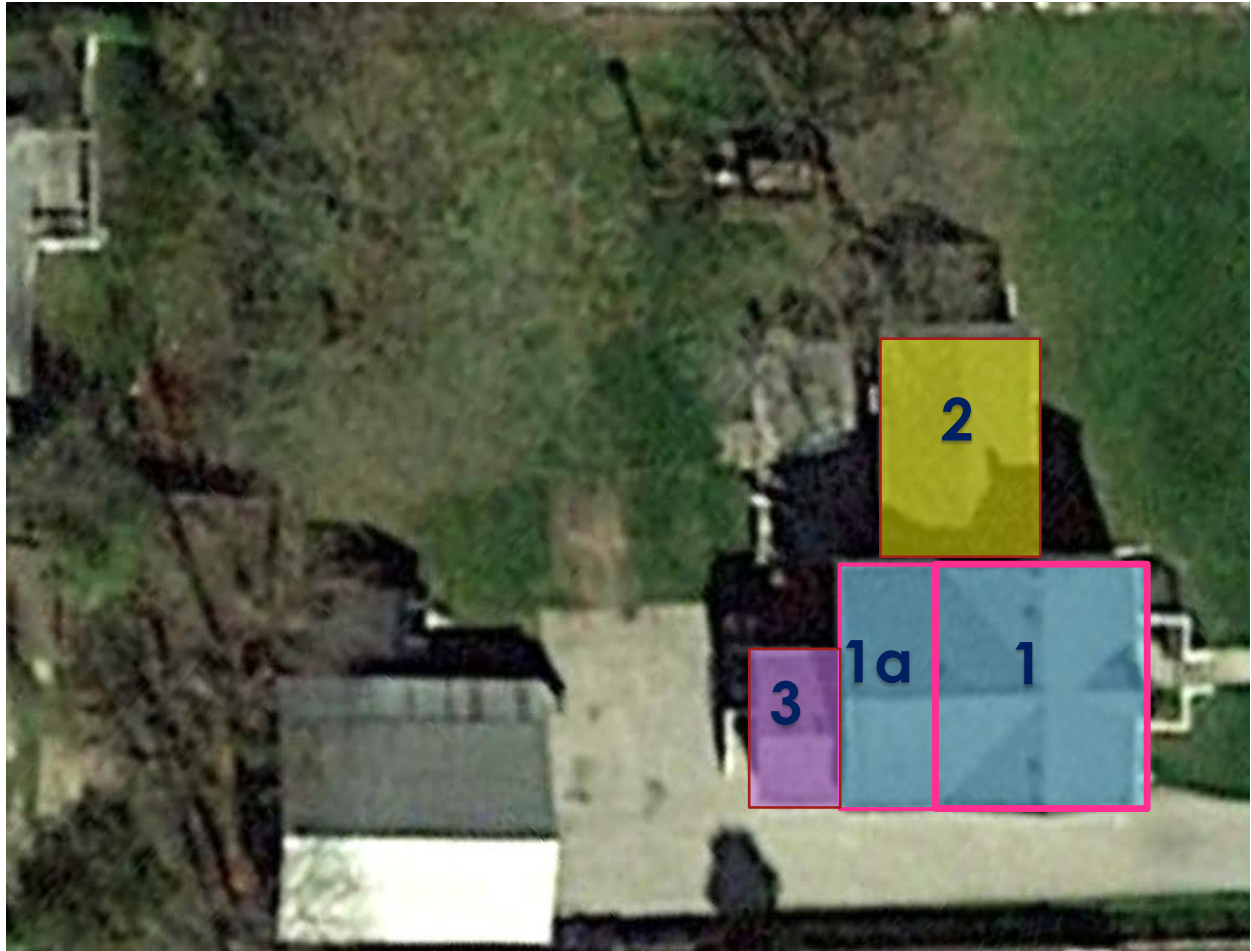
Figure 25: 32 Connaught Street. Original building as labelled with a "1" was built circa 1910 and then followed by two additions, labelled (Source: Google Earth, 2021; annotated by SVMA).

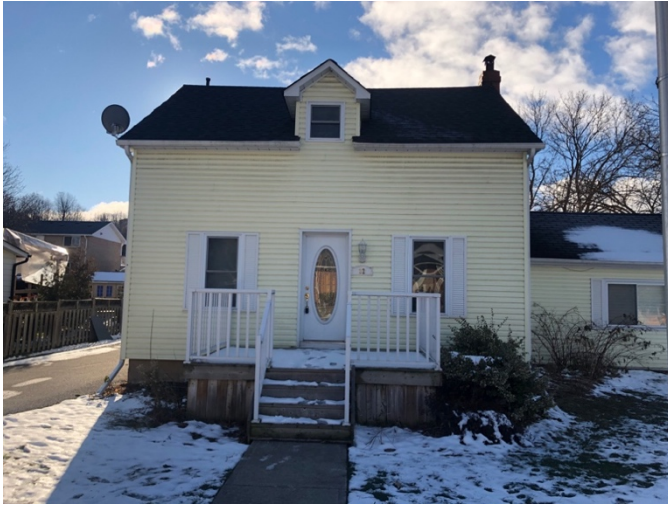
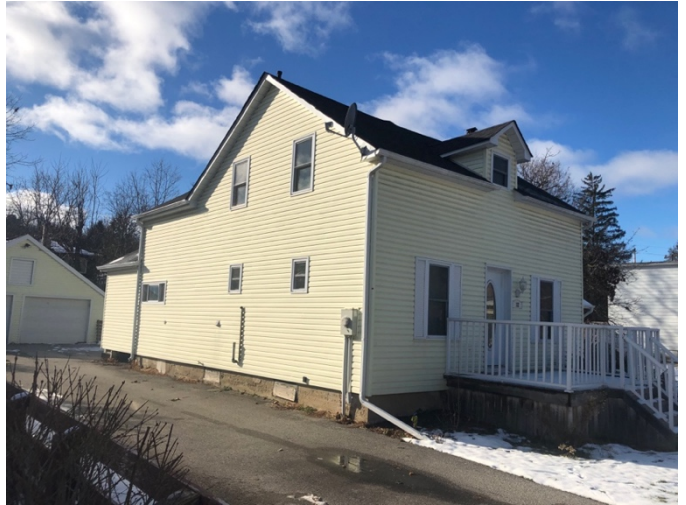
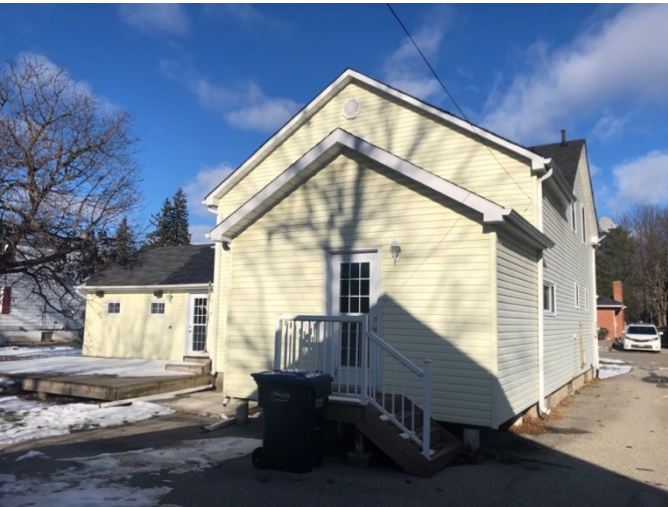
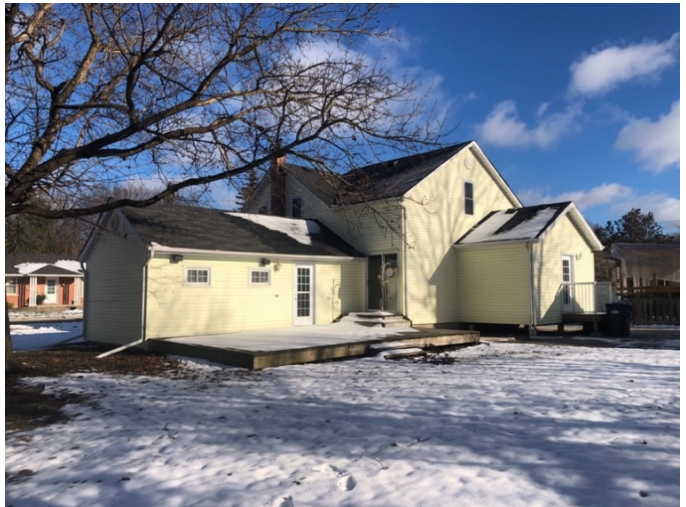
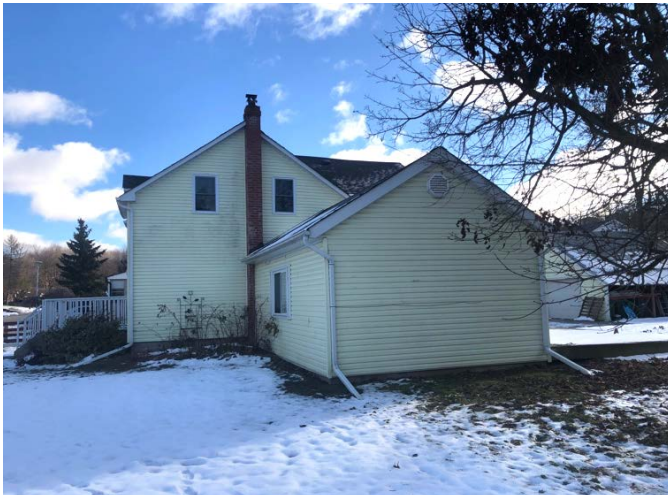
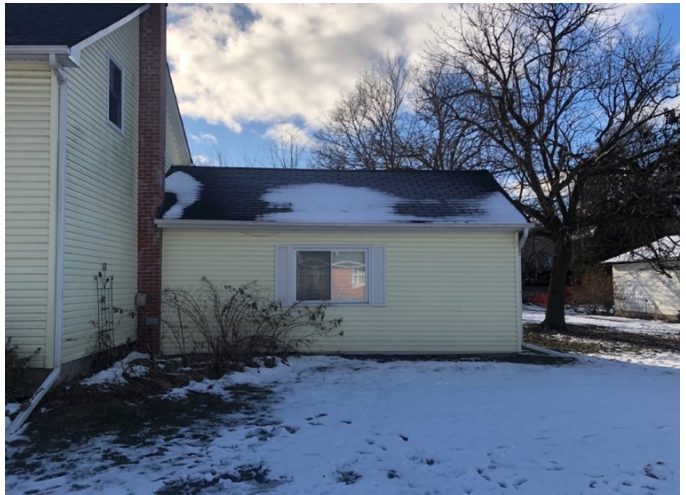
Figure 26: Existing exterior elevations of 32 Connaught Crescent as taken on December 6th, 2020. Starting on the top left is the main east elevation, moving to the south, west, north and then east again.

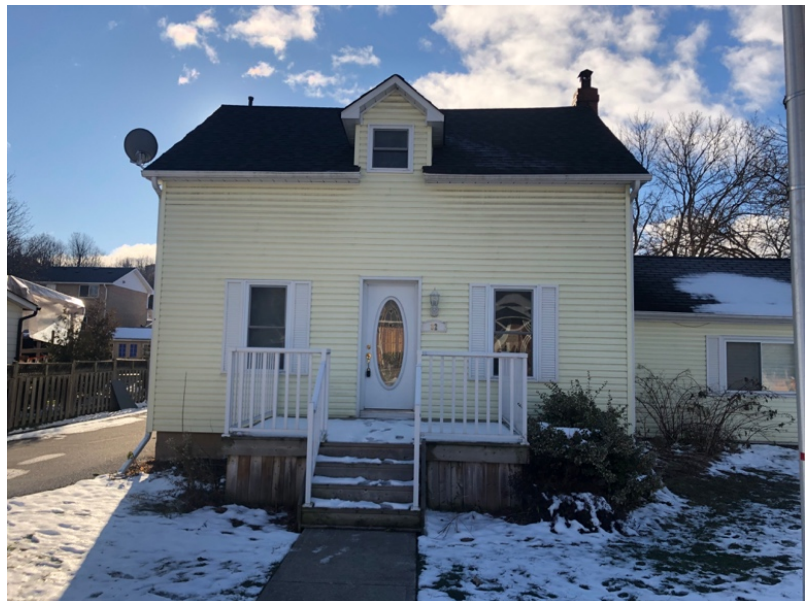
There is an exposed red-brick chimney on the north side of the façade. There is an entrance porch; however, it is not original. The railing is not authentic.

Figure 27: East (main) elevation showing the original dwelling of the site.

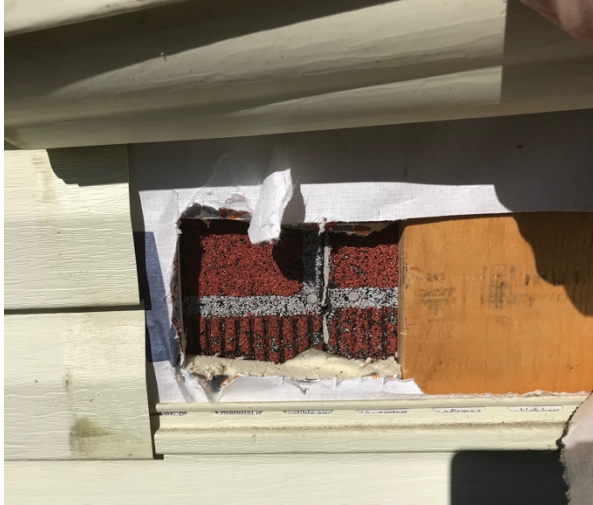
Through investigation of the exterior, an uncovering of an asphalt fibre cladding used in buildings during the 1930s, and other information gathered on land transfer, the date of construction is estimated at circa 1930s. The centre dormer above the main entrance is also believed not to be original.

Figure 27a: Cladding below the vinyl siding is an asphalt and fibre product known as “Insulbrick”

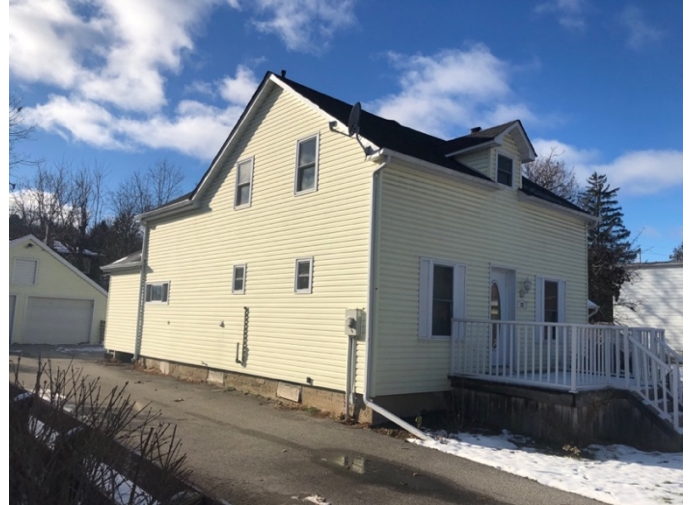
Figure 28: South elevation.

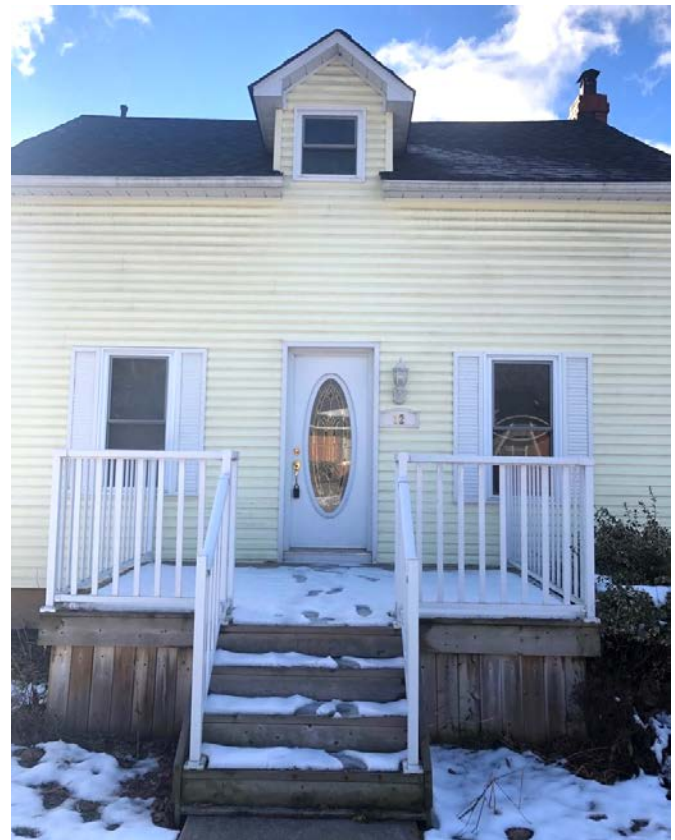
On the main façade, there are two symmetrically placed windows on either side of the entrance door and a window centred in the dormer above. The

Figure 29: East elevation, main entrance, windows, central dormer and porch.

original windows have been replaced with double-glazed glass in vinyl casings. The window shutters have also been replaced with vinyl.

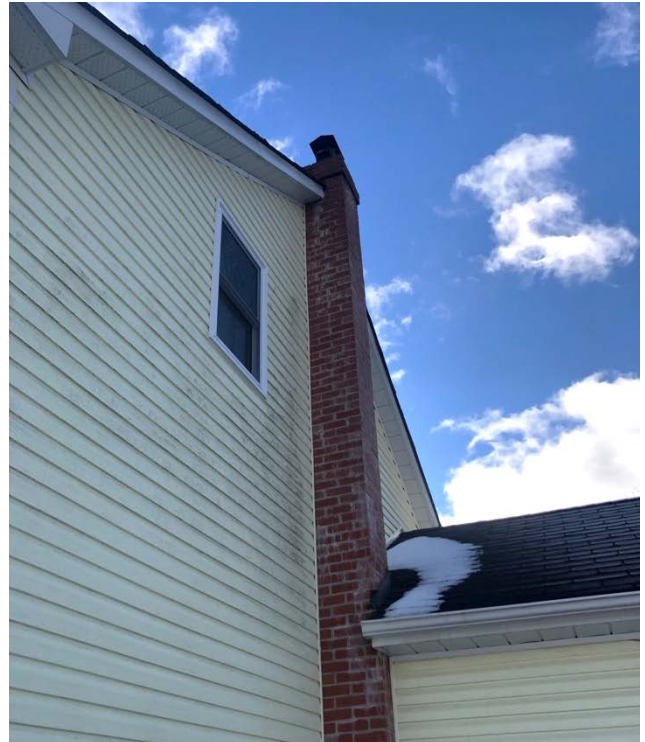
A brick chimney is located on the north side of the original building. It appears that portions of the chimney were repaired and reconstructed with new brick. The brickwork shows signs of efflorescence and deterioration of the mortar joints at the top. Generally, it is in good condition.

Figure 30: View of brick chimney.

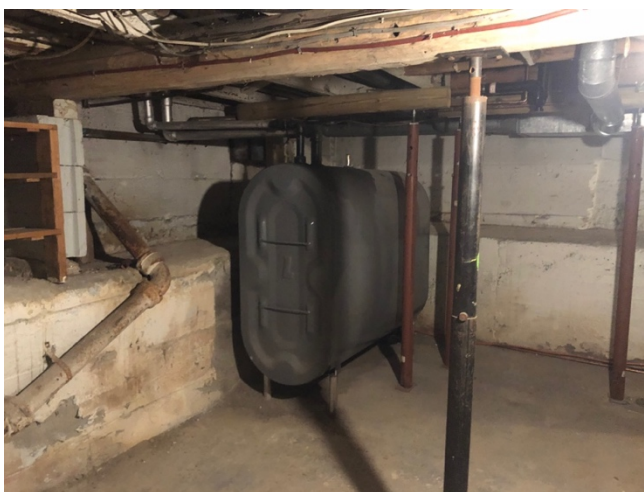
The original house (Section 1) consists of board-formed concrete with a perimeter bench. The structural assessment observed cracking in the concrete wall. It is unclear whether the bench footing is adequately constructed. The foundation is in poor condition and would require an extensive report. The foundations of Section 2 are a slab on grade with concrete block foundations. The structure report note that it is in good condition. The foundations of Section 3 consist of concrete piers. The structural report note that it is in good condition.

Figure 31: Interior view of foundation.

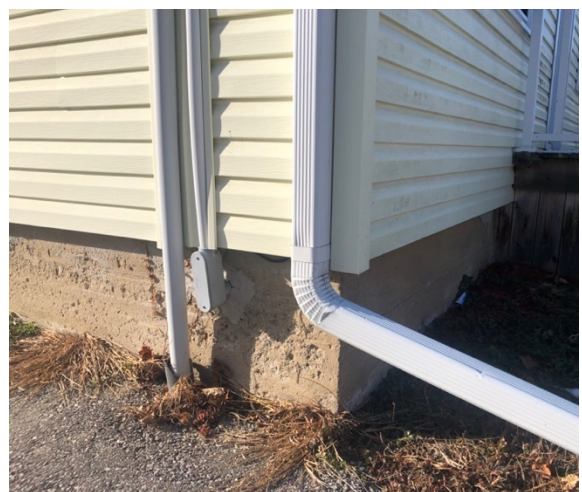
Figure 32: Exterior view of the foundation.

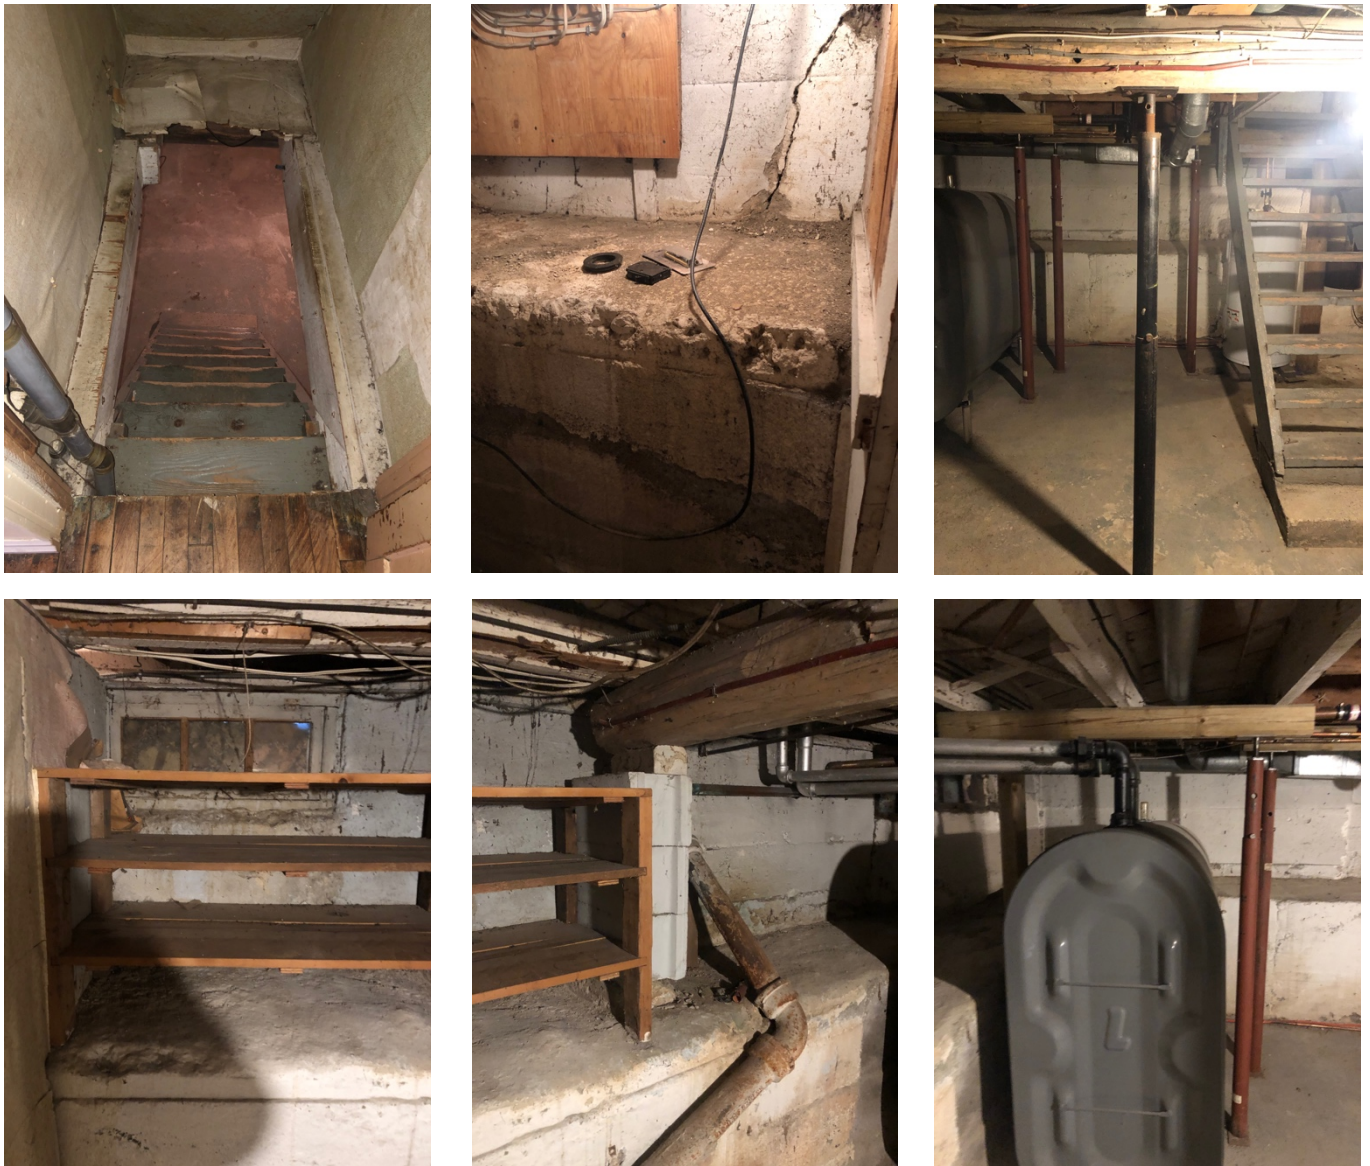
Figure 33: Views of the basement showing the temporary support of the existing structure.

The ground floor joist runs in a north-south direction to a central beam located mid-way through the span. The central beam and floor joist were visibly sagging and were propped up with temporary jacks and woodblock support. The ground floor framing is in poor condition and requires extensive repair. The structural report notes that the central beam is structurally insufficient and requires replacement. As

well, the existing ground floor joist is out of level and requires replacement. As well, there is no beam to support the ground floor load-bearing wall.

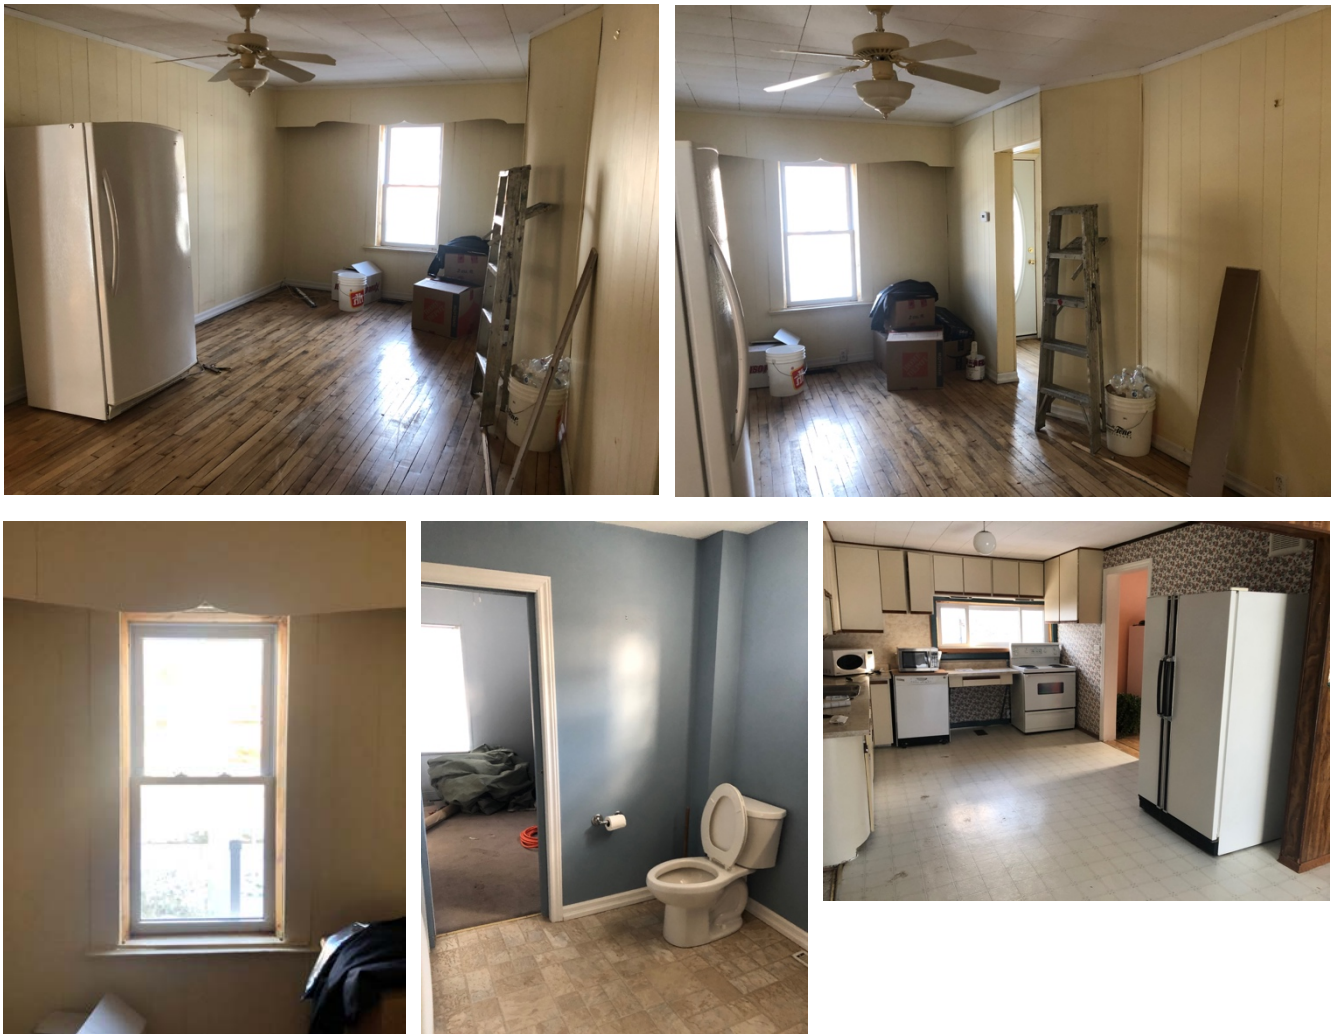
The floor plan is a central entry hall and stairs. There are three rooms as part of the original section (Section 1), one larger to the north and two smaller to the south, including a bathroom. The floor plan of the space was altered from the original layout. The kitchen is located off of the great room, in the rear second addition to the west. The latest side addition to the north is two steps down from the rest of the floor level. The interior finishes are of modest finish and in poor condition.

Figure 34: Views of the ground floor.

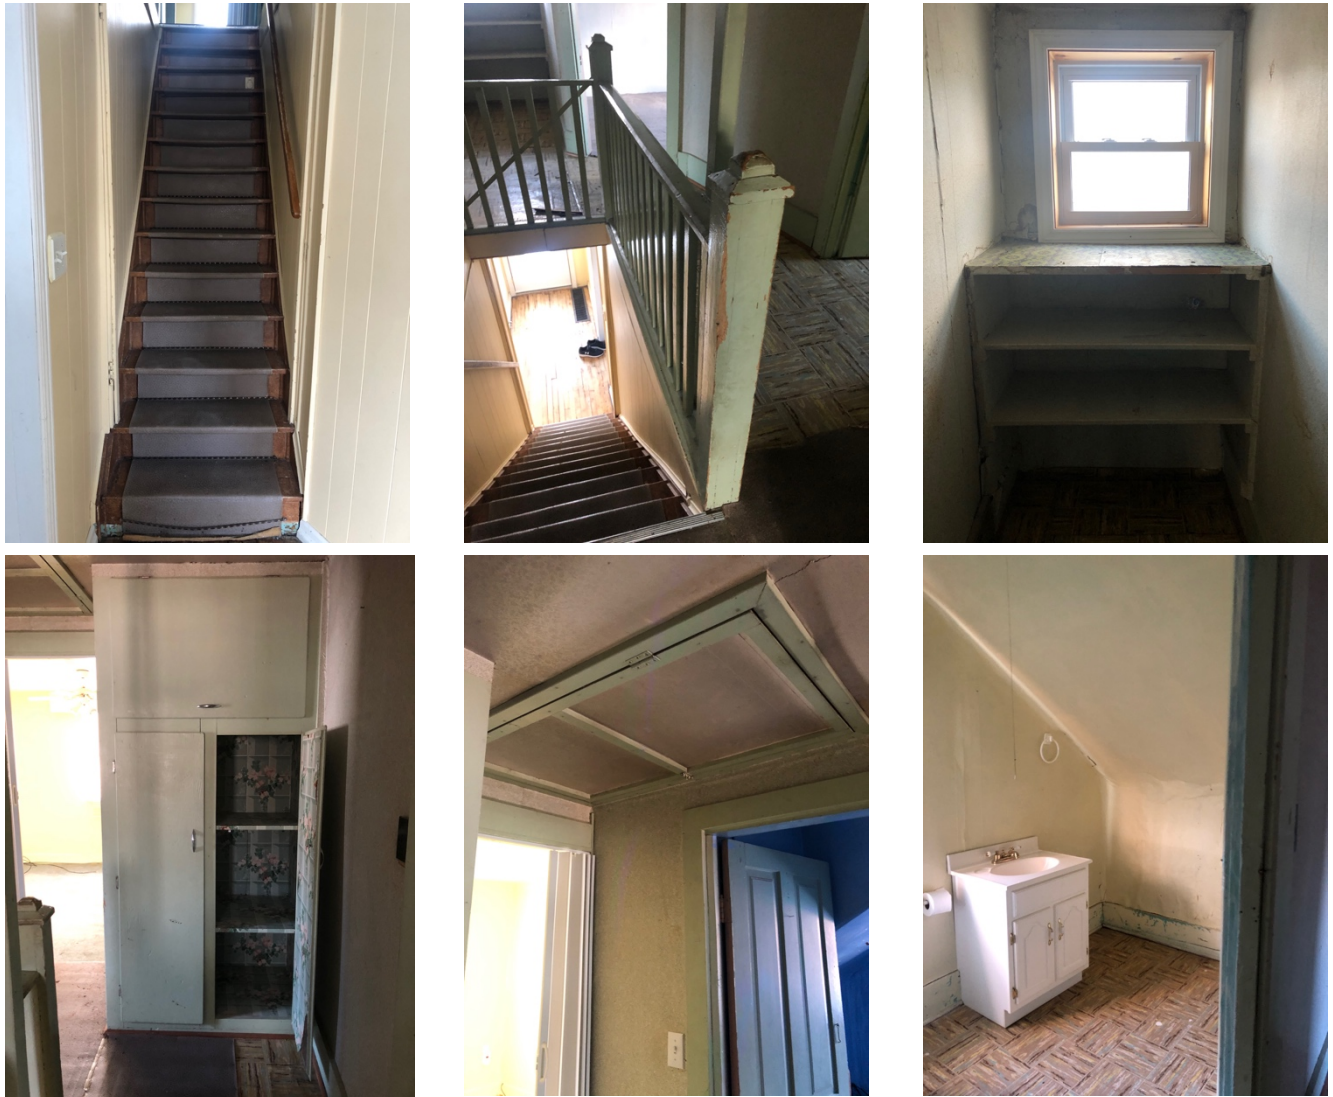
Moisture damage is visible in the original plaster finish, and generally, the finishes are in poor condition.

Figure 35: Views of the second floor

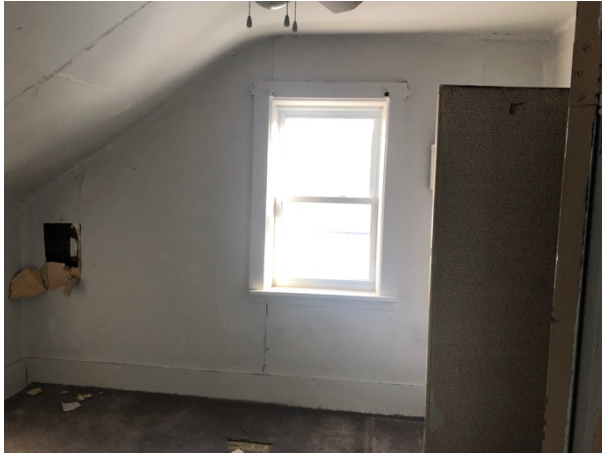
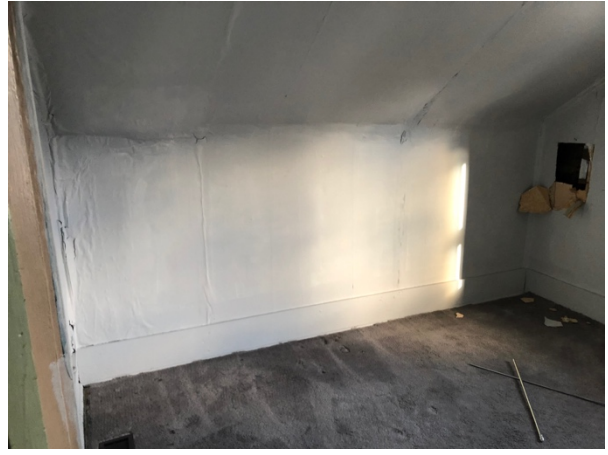
Figure 36: View of a bedroom on the second floor.

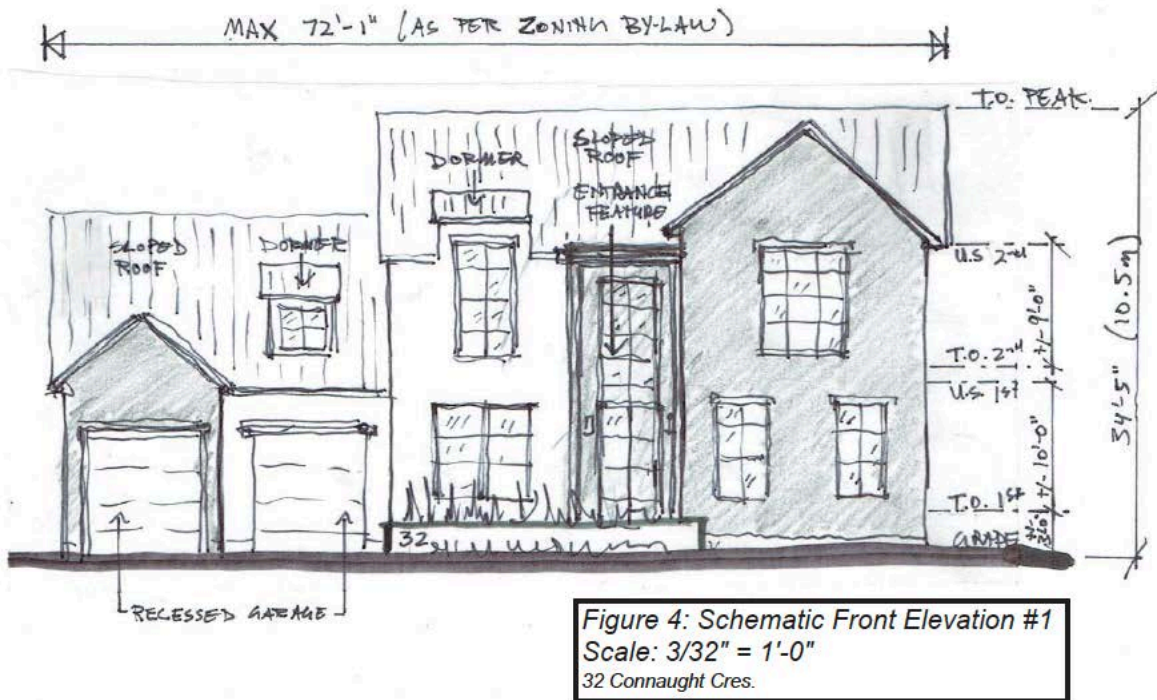
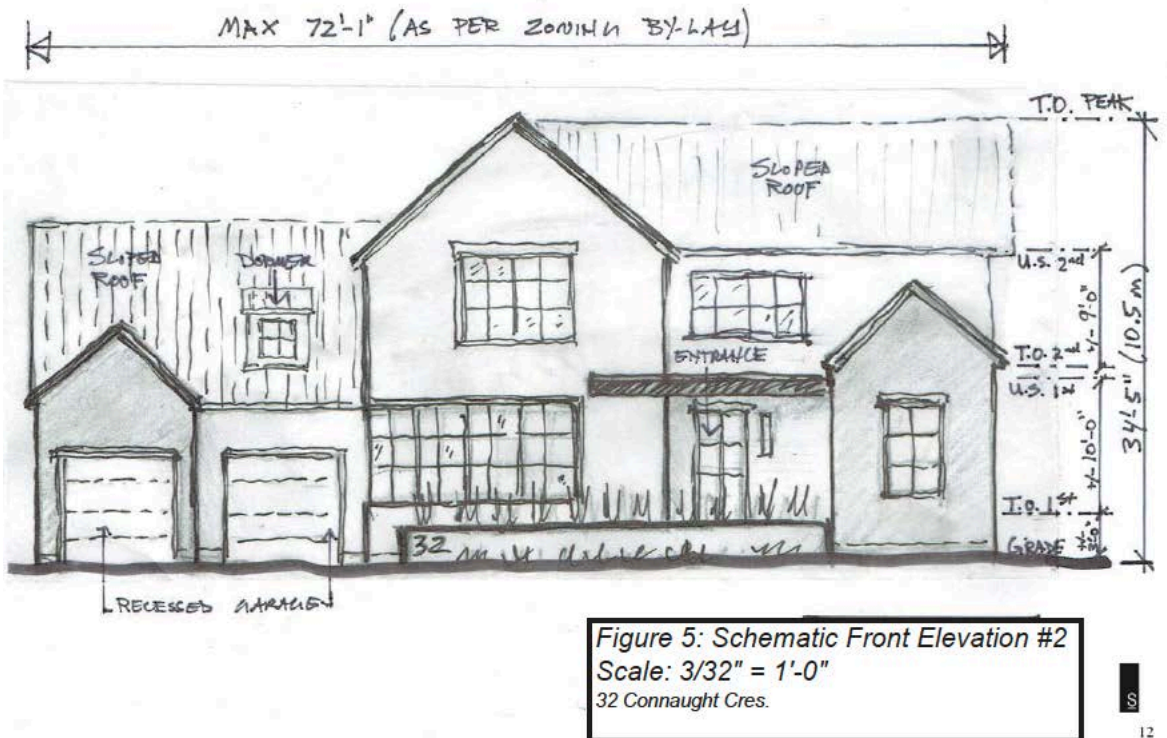
Figure 39: Proposed concept elevations, option 1 and 2. Provided by Studio Spagnolo Inc.

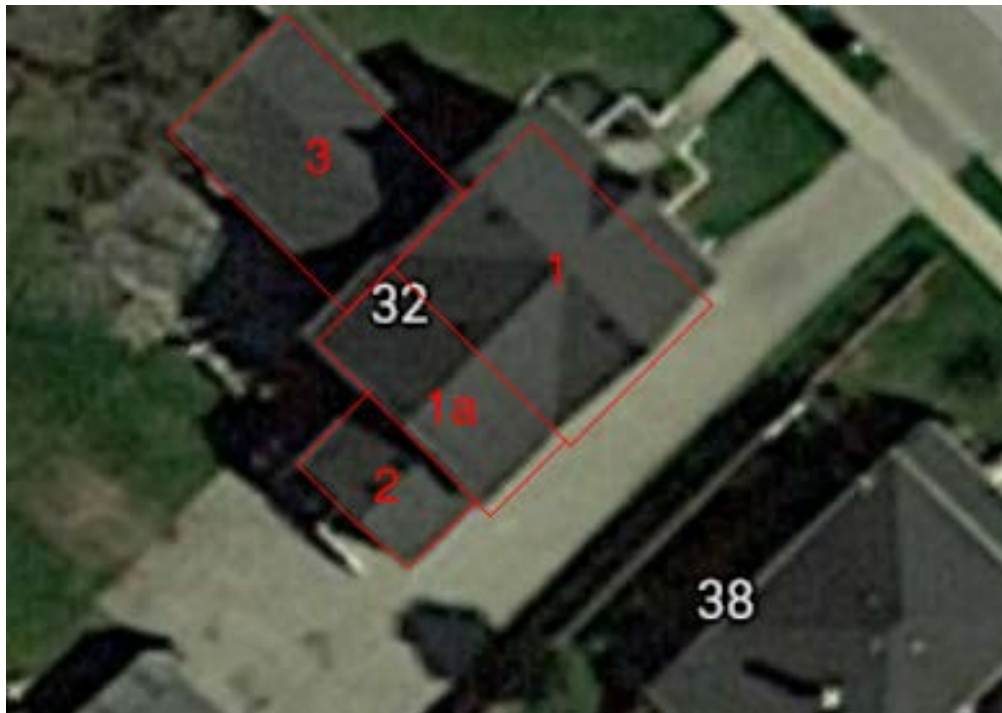
The existing building is a single family, fully detached dwelling. Our observations for the building are broken into three sections, as shown in the image below.

- Two Story wood framed construction with basement. Section 1 consists of the original building, section 1a was an addition to the existing building. This portion of the building is in poor condition and is in need of extensive repairs, as noted below.
- Roof framing Consist of Sloped 2x4 rafters@24" o.c. with decking and 2x4@16" o.c. ceiling framing. Roof framing does not meet the requirements of the Ontario Building Code 2012 (OBC) and requires reinforcement.

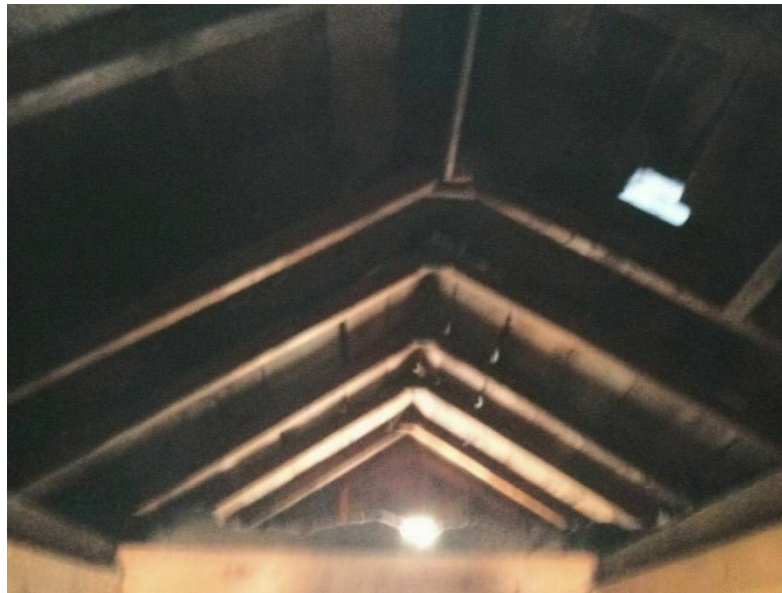
- The roof finishes consisted of a ¼" thick cardboard like material that was not identified. All finishes on the second floor needed to be removed and replaced.

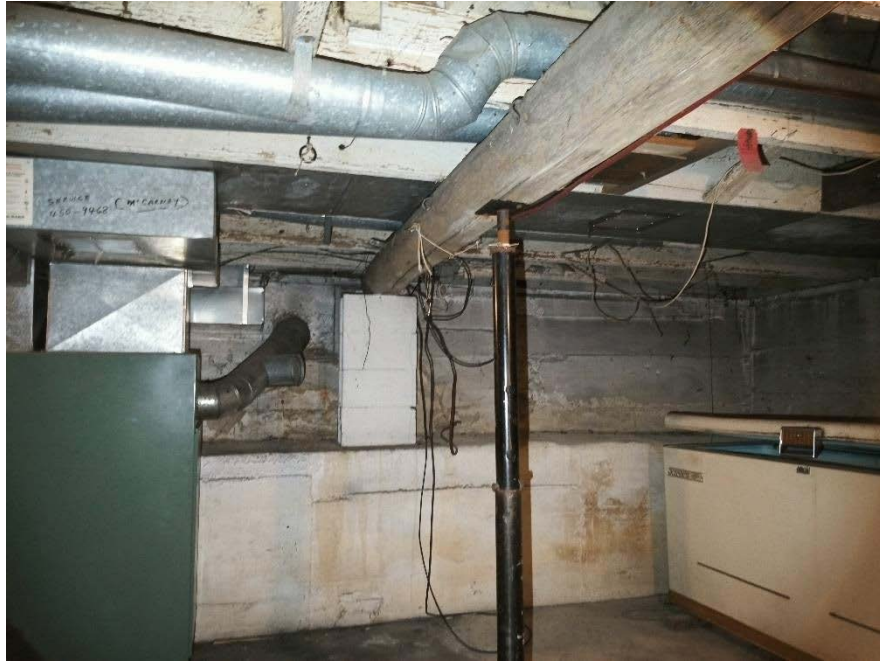
- The existing ground floor joists were out of level and required replacement.
 - There was no beam to support the ground floor load bearing wall.
- The original building foundations consist of board formed concrete with a perimeter bench. Periodic cracking was observed in the concrete wall. It is unclear whether the bench footing is adequately constructed. The foundation wall requires repair, further investigation is needed to determine the extent of the repair.

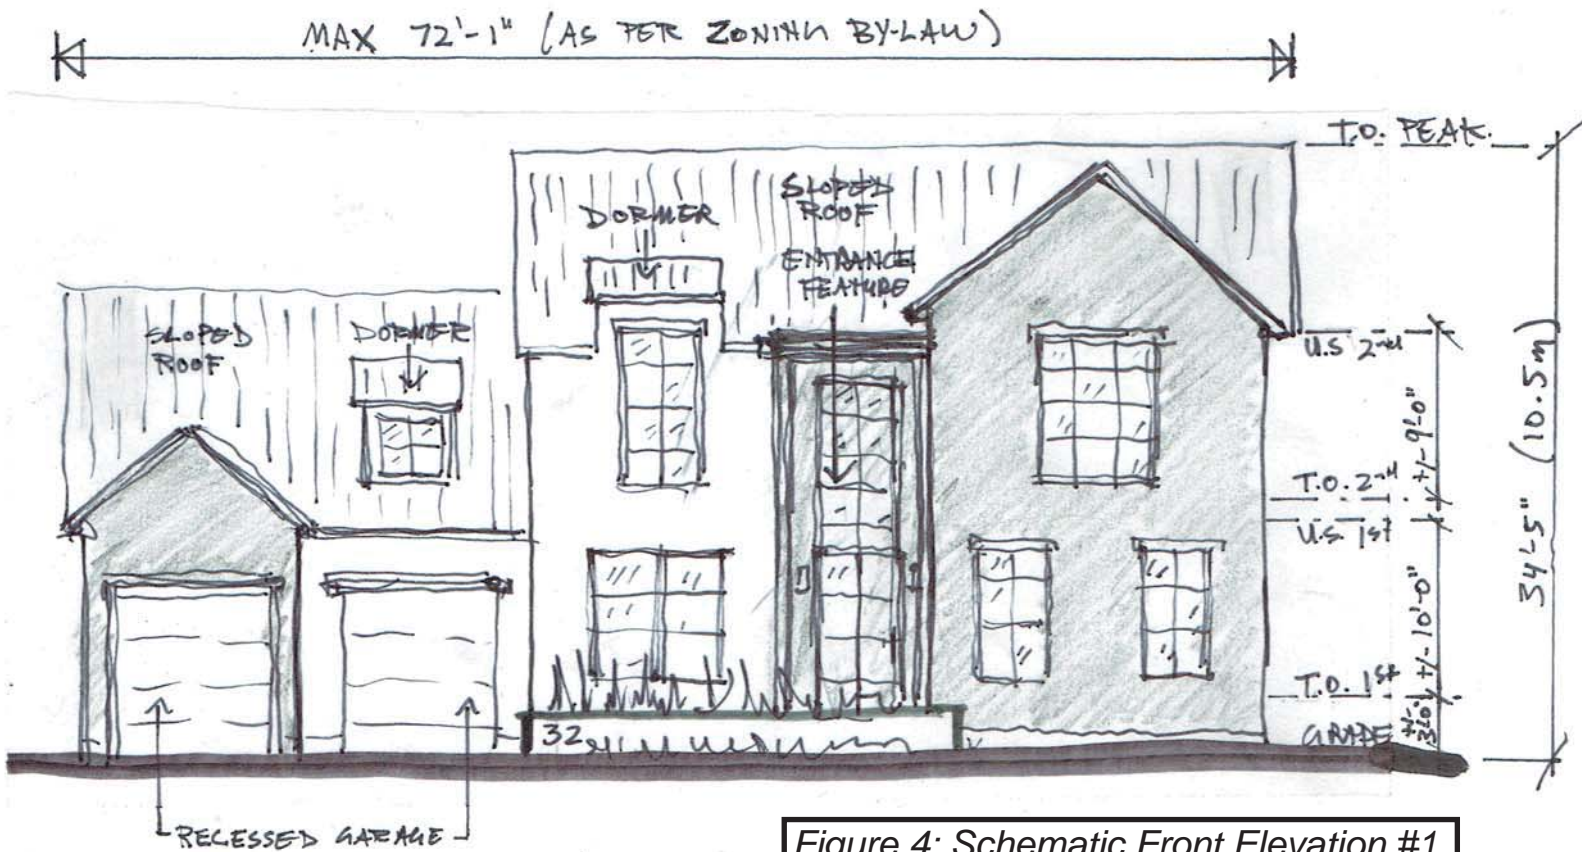
Figure 4: Schematic Front Elevation #1

Scale: $\frac{3}{32}'' = 1'-0''$

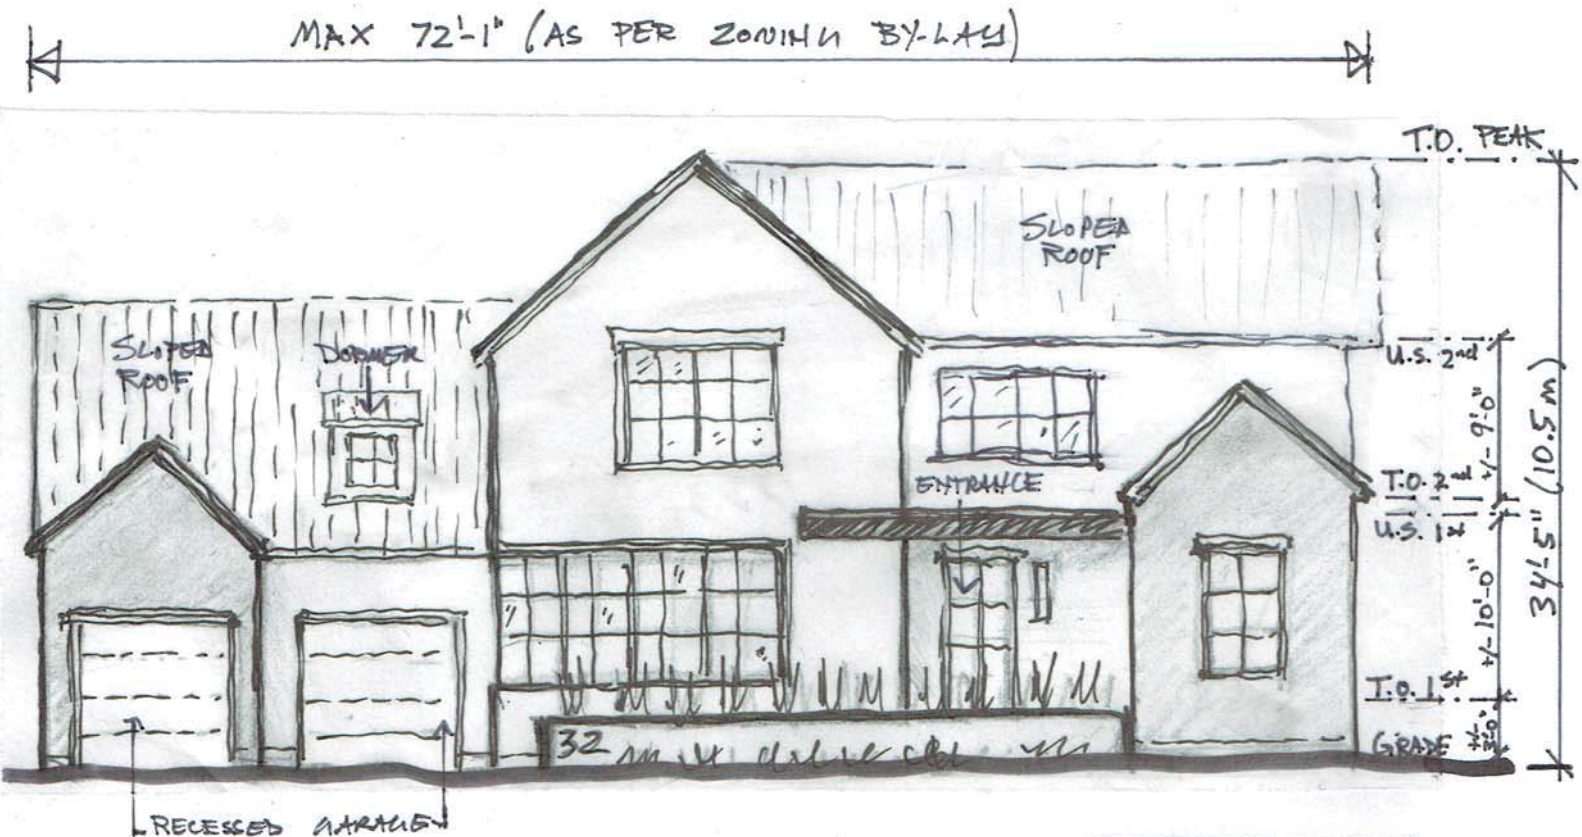
Figure 5: Schematic Front Elevation #2

Scale: $\frac{3}{32}'' = 1'-0''$
