Subject: Recommendation to Remove Structure from Heritage Register – Kennedy Road Bridge (B260-64020), Ward 1

**CULTURAL HERITAGE DOCUMENTATION REPORT:
KENNEDY ROAD BRIDGE (B260-64020)**

TOWN OF CALEDON, ONTARIO

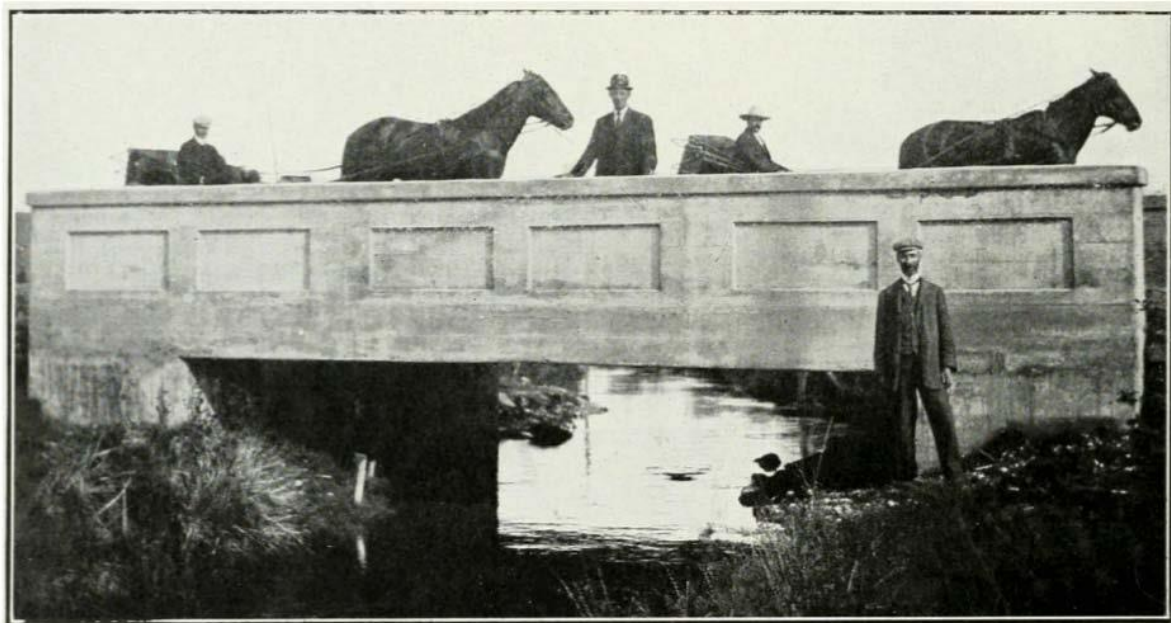
Reinforced Concrete Beam Bridge over the Credit near Orangeville. Clear Span, 22 feet ; Length over all, 34 feet ; Clear Width of Roadway, 20 feet ; Height of Walls, 13 feet 6 inches. Walls, Floor, and Girders are Concrete, Reinforced with Steel Rods. Cost —Concrete, \$448.00 ; Steel Reinforcing, \$85.00.

Figure 2: “Reinforced Concrete Beam Bridge over the Credit Near Orangeville.” The solid concrete handrails with recessed panels are similar to the Kennedy Road Bridge [Annual Report on Highway Improvement Ontario for 1911, No. 14, 106].

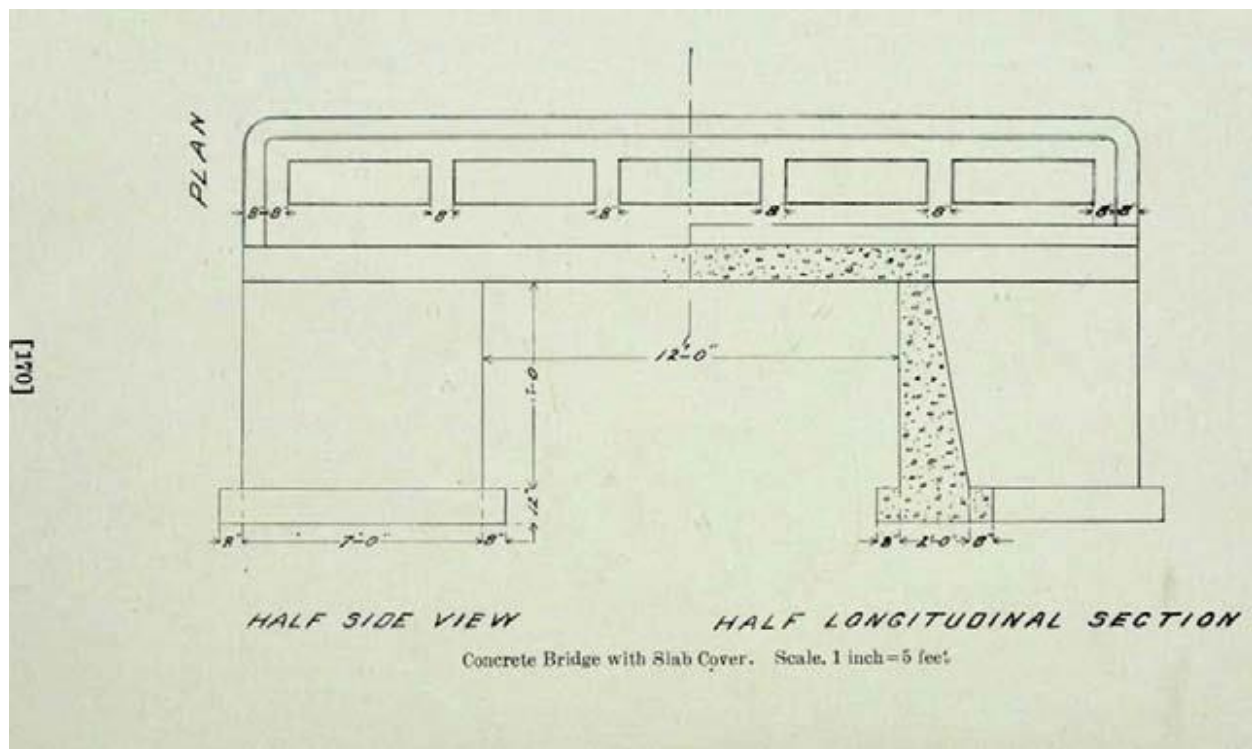
Figure 3: Half longitudinal section of a typical concrete bridge design with slab cover [Annual Report on Highway Improvement Ontario for 1910, No. 14, 170].

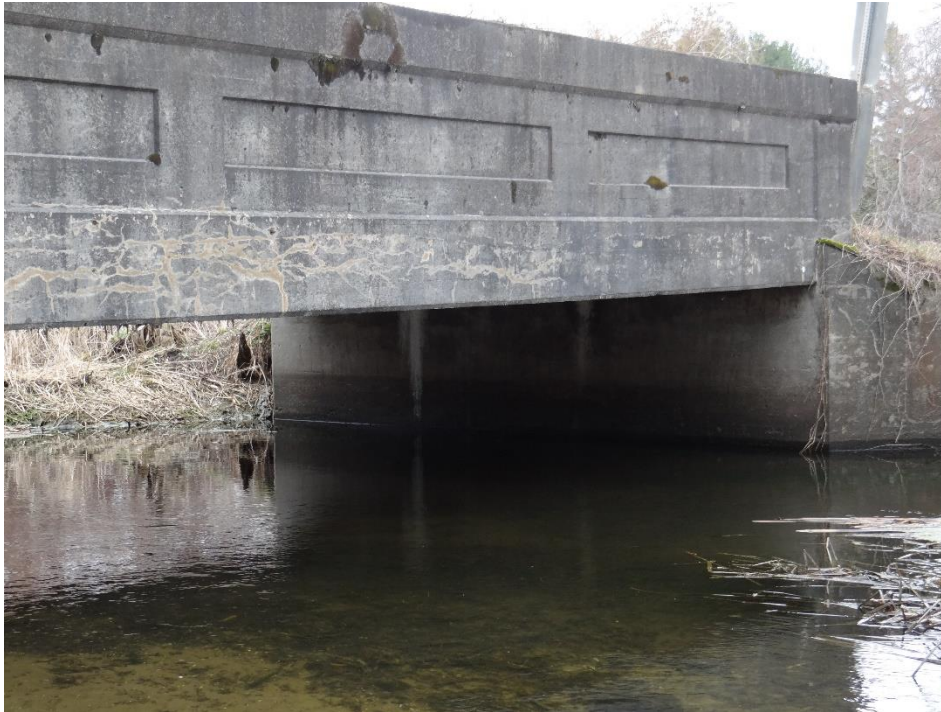
Plate 7: View of the Kennedy Road Bridge east parapet wall and north abutment, looking northwest

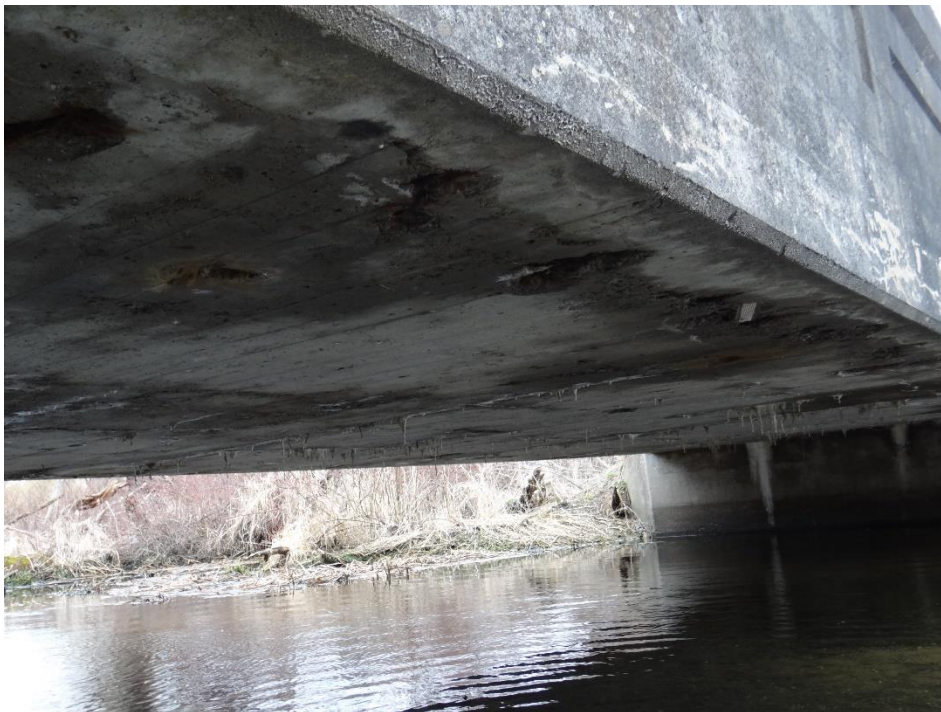
Plate 12: View of the deck soffit of Kennedy Road Bridge, looking northwest

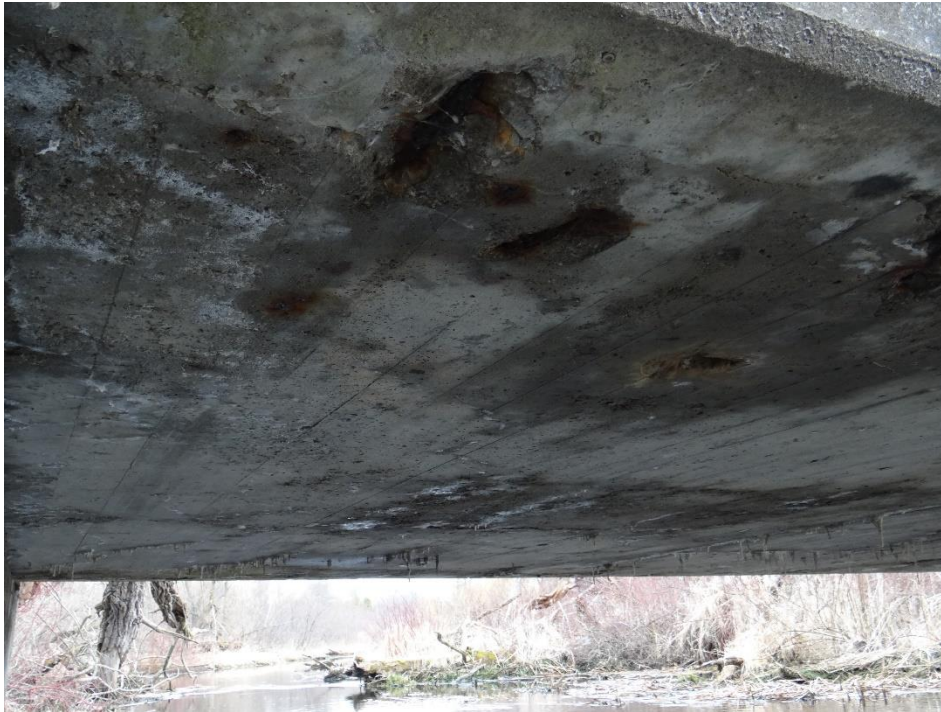
Plate 13: View of
the deck soffit of
Kennedy Road
Bridge, looking west

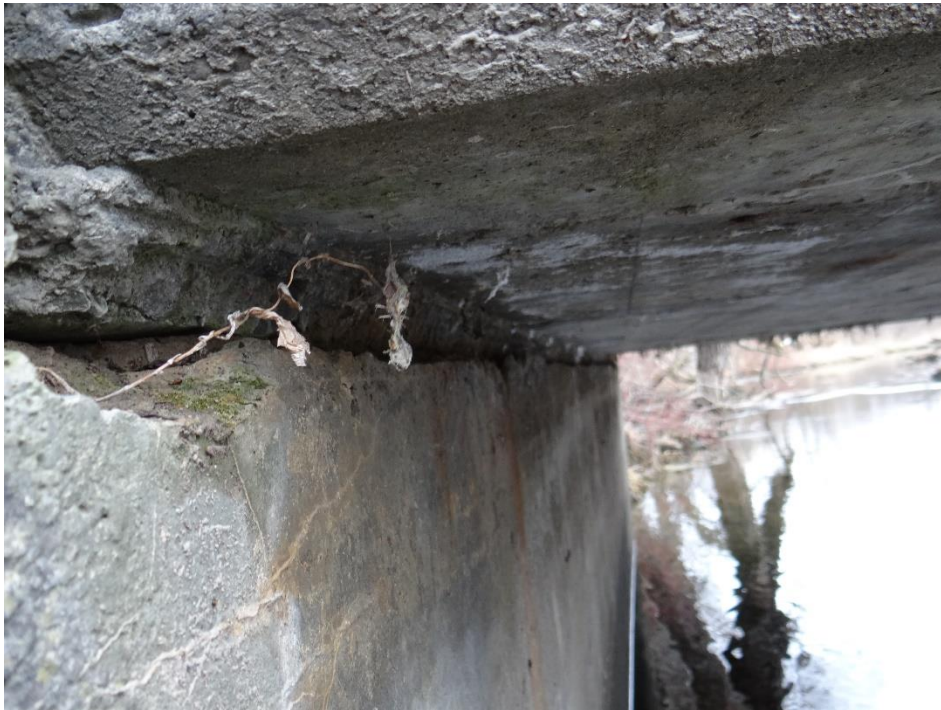
Plate 14: View of
south abutment
expansion gap from
the southeast
corner, looking west

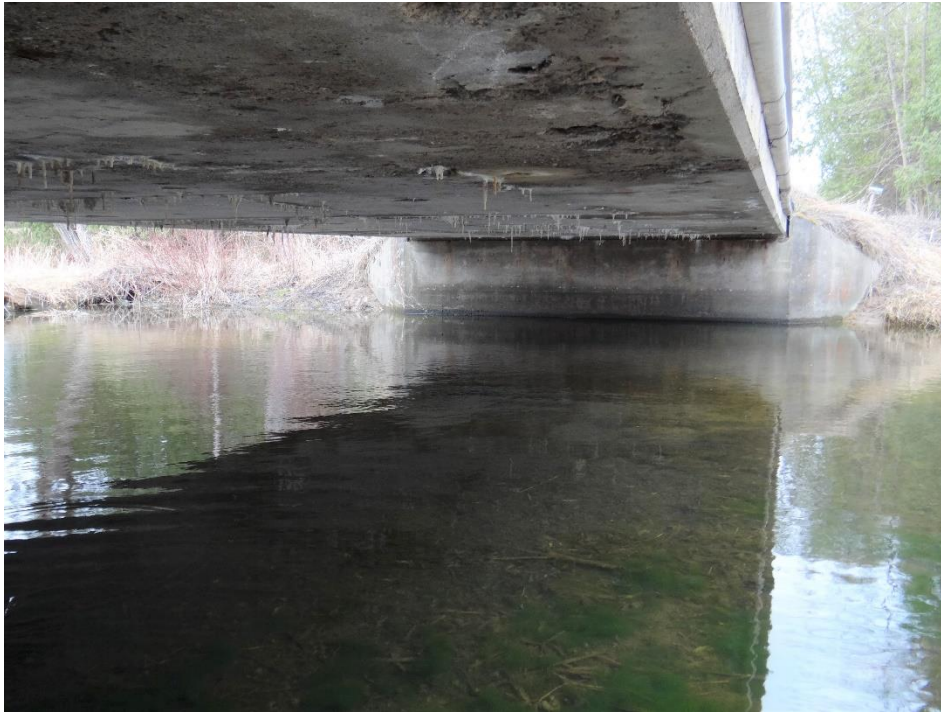
Plate 15: View of the south abutment and wingwalls of the Kennedy Road Bridge, looking south

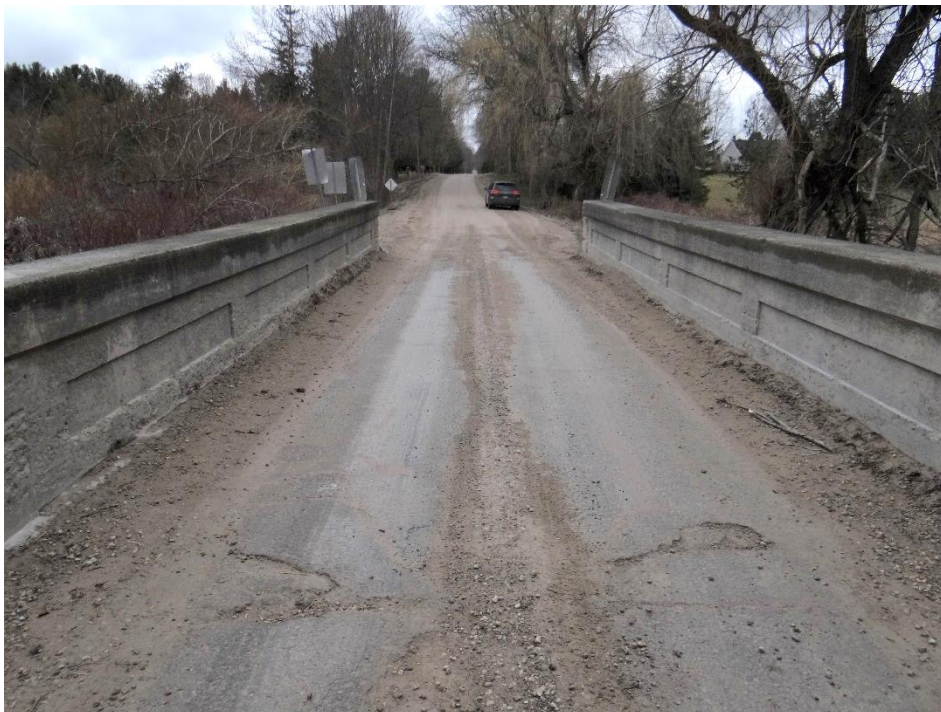
Plate 16: Kennedy Road Bridge road surface, parapet walls, and handrails, looking north

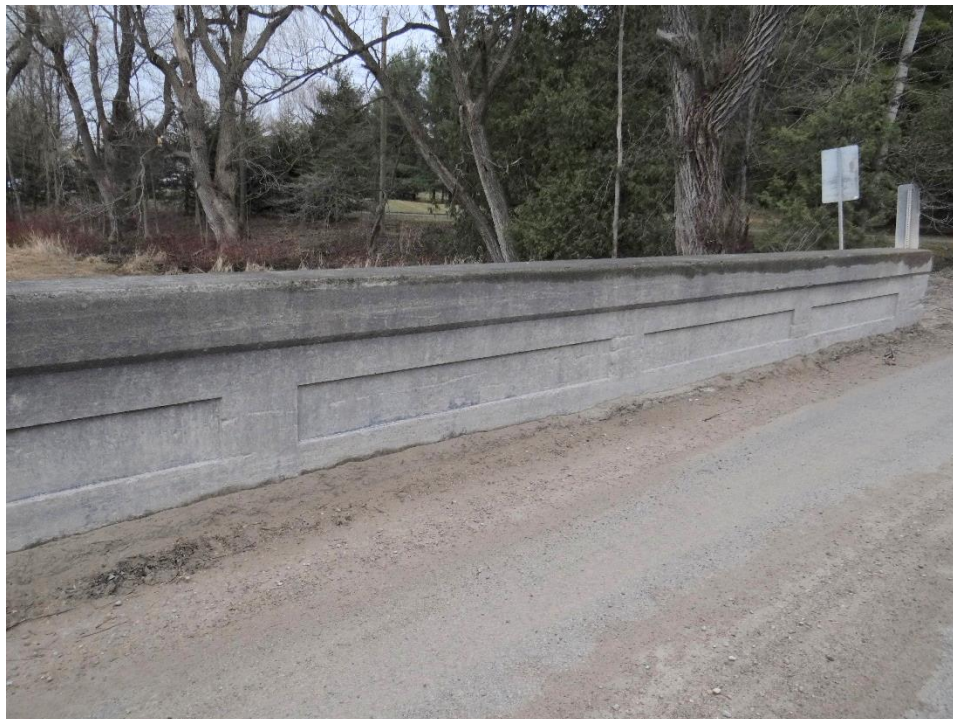
Plate 18: East
parapet wall,
handrail, and
decorative panelling
of the Kennedy
Road Bridge, looking
southeast

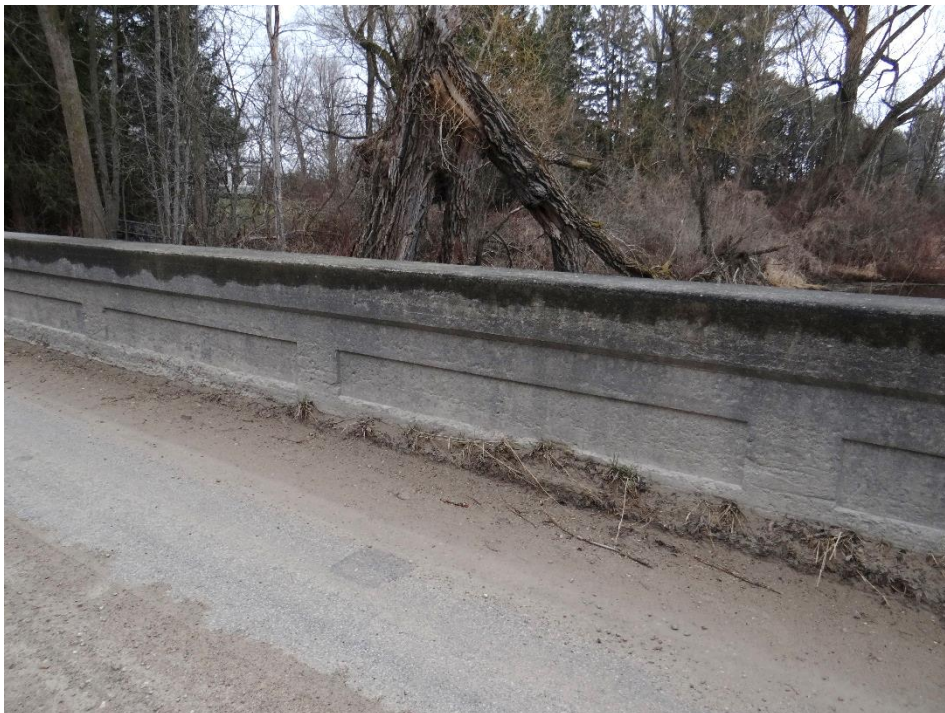
Plate 20: West
parapet wall,
handrail, and
decorative panelling
of the Kennedy
Road Bridge, looking
southwest

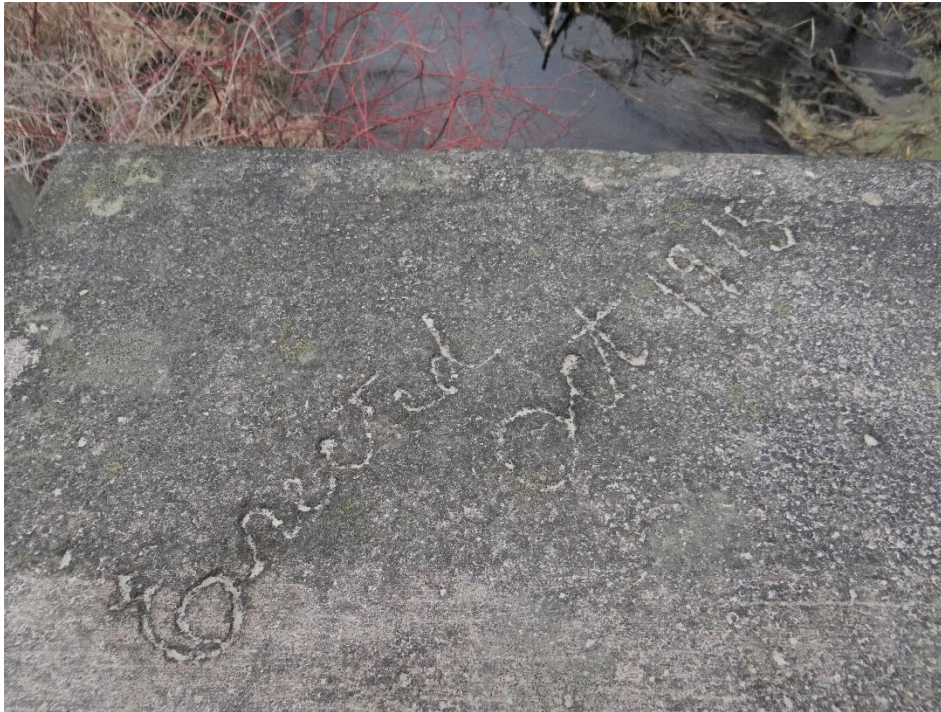
Plate 25: Etching
inscribed on east
handrail reading
"Erected Oct 1915"

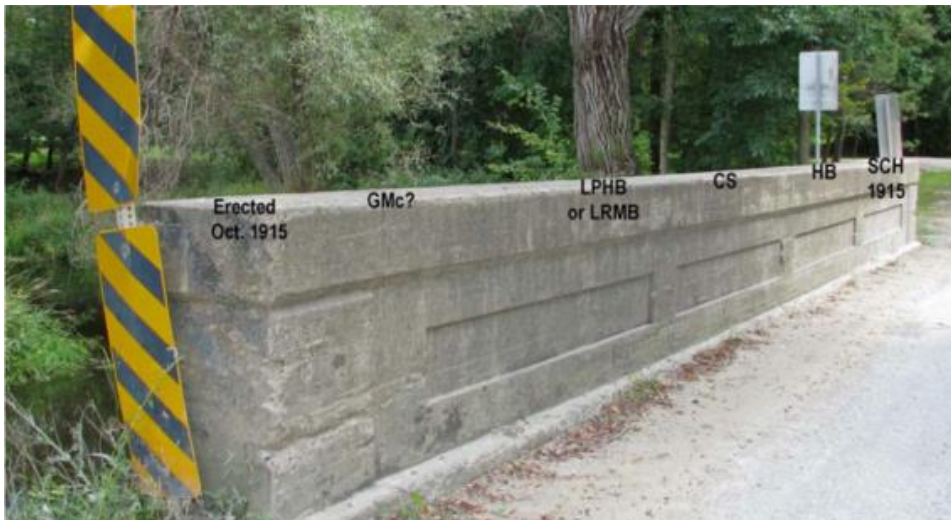
Plate 40: East
handrail (north left)
showing the
approximate
locations of the
various inscriptions
(Unterman McPhail
Associates 2015
Appendix B)

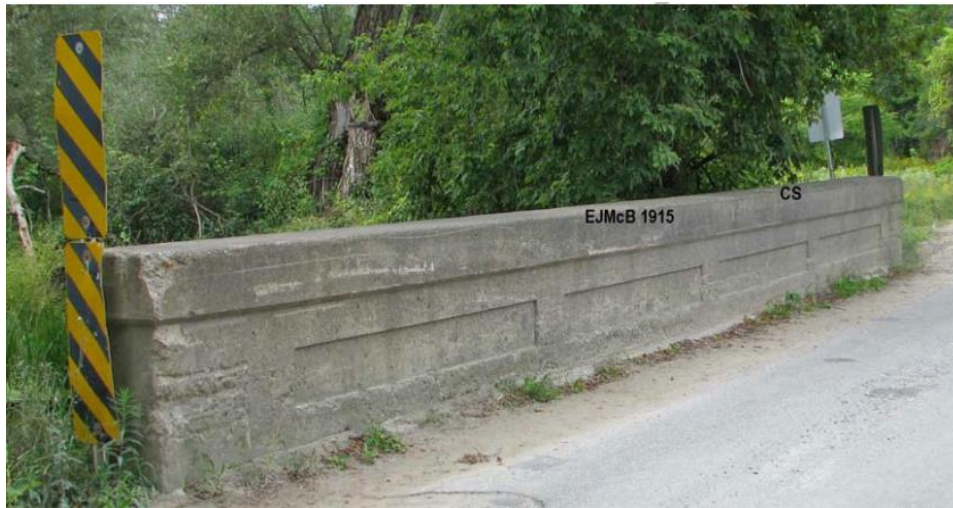
Plate 41: West handrail (south left) showing the approximate locations of the inscriptions (Unterman McPhail Associates 2015 Appendix B)
