Staff Report 2022-0262

Meeting Date:	June 6, 2022
Subject:	Notice of Intention to Designate – 12035 Dixie Road, Ward 2
Submitted By:	Candice Bogdanski, Heritage Planner, Strategic Policy Planning

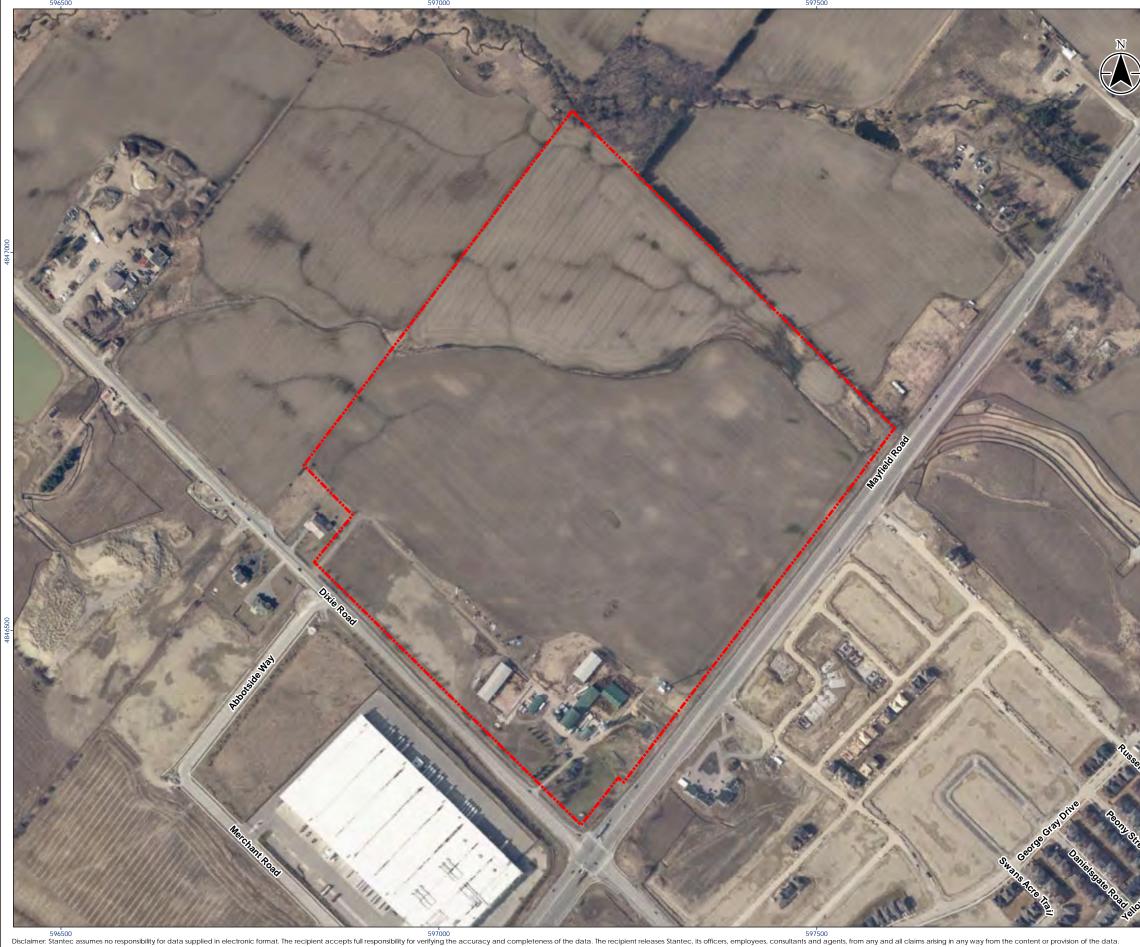
The proposed redevelopment of the site includes the construction of four industrial buildings of 204,720 square feet to 1,330,336 square feet in size. This industrial development is proposed to be set back from the existing structures by at least 100 metres.

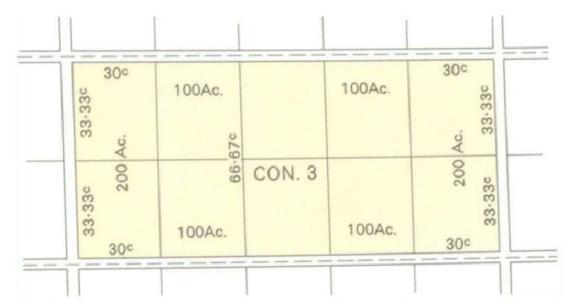
Plate 1: Double Front Survey System (Dean 1969)

The Township of Chinguacousy was surveyed in the double front survey system (Dean 1969). The double front system was widely used in Upper Canada between 1815 and 1829. This survey system created lots of 200 acres with road allowances located in front of each concession and every fifth or sixth lot (Plate 1). This system allowed 100-acre grants of half lots since road allowances were located on both the front and rear halves of the lot (Weaver 1968: 14,16). The exact origin of the township name is unclear, but it is believed to have been named after a half Scottish, half Indigenous chief "Shinguacose" who participated in the capture of Fort Michilimackinac during the War of 1812 (Gardiner 1899: 234; McKinney 1967: 244).

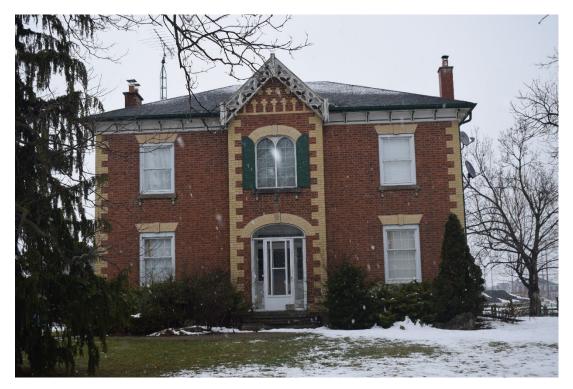
Plate 8: Front (west) façade of 12035 Dixie Road, looking east with projecting gabled roof bay with buff brick quoins

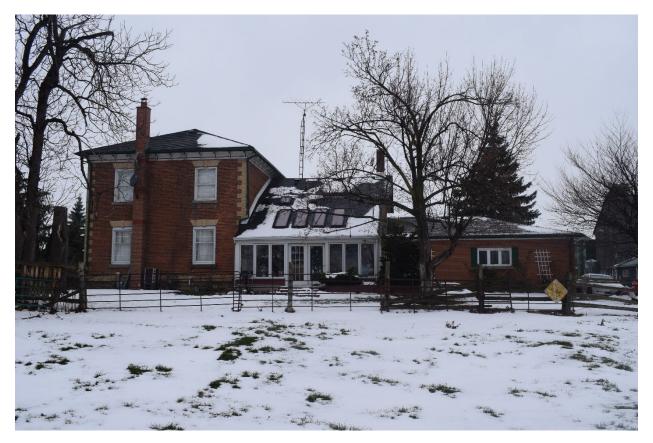
Plate 15: South façade, looking north

The centre portion of the south façade contains a shed roof addition which extends from the gable roof part of the east façade. This shed roof addition is a modern sunroom with modern windows and modern doors and a concrete foundation (Plate 18). The east section of the south façade contains part of a mid-20th century addition which includes a garage, modern windows, and a red brick exterior. The foundation of the addition is concrete block (Plate 19).

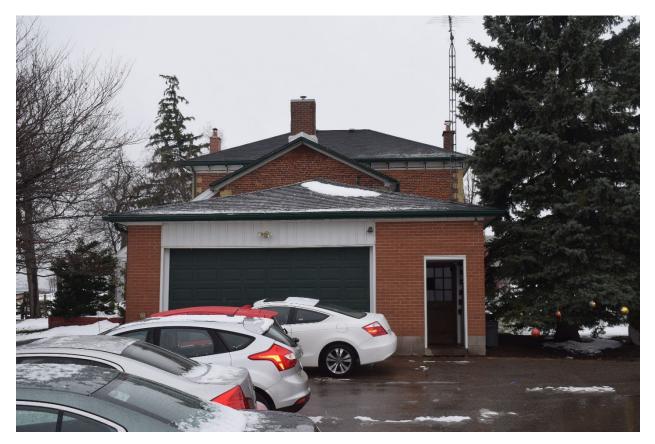
Plate 20: East façade, looking west

The east façade has been heavily modified by a shed roof addition and mid-20th century hip roof addition. Original sections of the east façade are clad in red brick with buff brick quoins. The west section of the east façade contains a wood fascia and wood brackets. The shed roof addition to the east façade is clad in modern siding and contains modern windows. The northern-most section of the east façade contains a modern garage and modern door. This addition is clad in red brick and has a concrete block foundation (Plate 20).

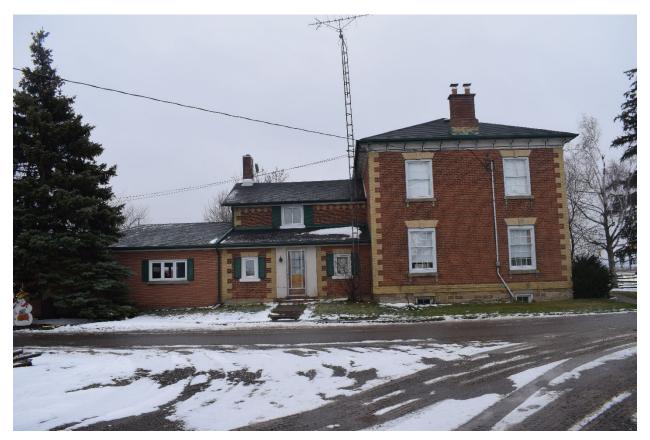
Plate 21: North façade, looking south

The north façade of the residence contains three distinct sections. The westernmost section has a red brick exterior with a common bond and a wood fascia and brackets below the roofline. The western section of the north façade has buff brick quoins and a buff brick band above the stone foundation. This section contains modern 8/8 windows on the second storey and modern 8/12 windows on the first storey with buff brick voussoirs with buff brick keystones and stone sills with buff brick brackets (Plate 21). The basement contains four pane wood frame windows (Plate 22).

The middle section of the north façade is an original section of the residence and contains a gable roof section with a brick chimney and asphalt roof shingles. The exterior is clad in red brick with a common bond and contains buff brick quoins and dichromatic decorative brickwork below the roofline. This section contains a modern horizontal sliding window on the second storey and modern casement windows with buff brick voussoirs on the first storey. The easternmost section of the north façade is part of the mid-20th century hip roof addition and contains a red brick exterior and modern windows (Plate 23).

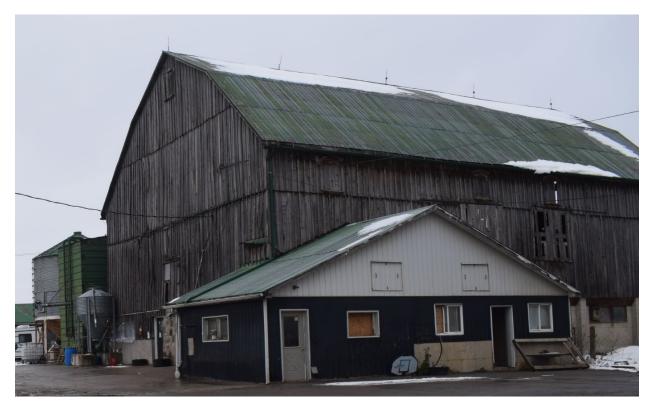
Plate 24: South and west elevations of the barn, looking north

The barn at 12035 Dixie Road is a gambrel roof barn. The barn contains a metal roof with five lightning rods. The exterior of the barn is clad in unpainted board and batten siding (Plate 24). The barn contains additions on the south and east elevations. The foundation of the barn is a mix of stone, poured concrete, concrete block, and brick. According to the occupant of the property, the entire barn originally had a stone foundation. During the 1980s, the stonework failed and was replaced by sections of poured concrete, concrete block, and brick. Only a small section of the original stone foundation remains on the west elevation of the barn (Plate 25). Based on visual inspection and information from the occupant, the barn was originally a bank barn. According to the occupant, the bank was an earth and concrete gangway which was large enough to allow vehicles to pass underneath. The bank was removed in the mid-1980s.

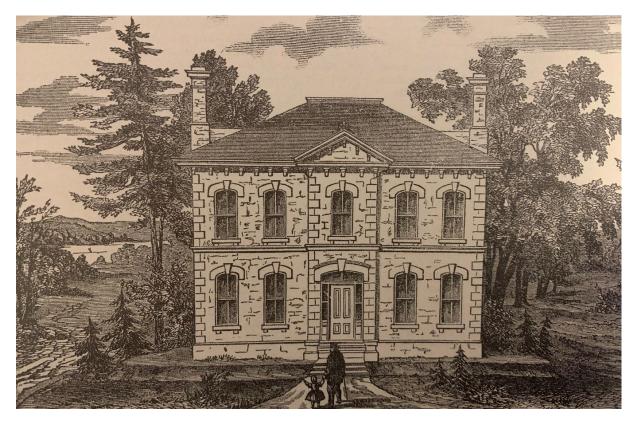
Plate 68: The two-storey farmhouse popularized by *The Canada Farmer* (Canada Farmer 1865)

Georgian elements of 12035 Dixie Road include the symmetrical front façade and overall square shape. Gothic Revival elements present at 12035 Dixie Road include the use of bargeboard in the gable of the projecting bay, as bargeboard is not often incorporated into Italianate design. The overall result of this design was a fairly conservative residence that offered a middle ground between more ornate contemporary designs and the older Georgian style. This resulted in this style of residence having a widespread appeal throughout southern Ontario (Blumenson 1990: 58-59).
