# Cultural Heritage Assessment Background Report

20469 Willoughby Road, Melville  
Town of Caledon, Ontario  
April 2024

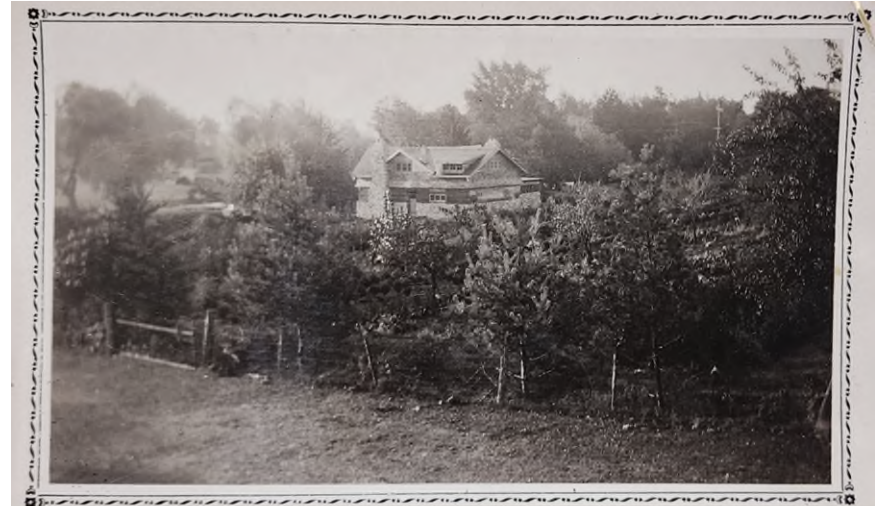
The house is seen in a black and white photograph taken from near the location of the barn in 1932. This view shows that the additions have not yet been made to the east side and rear of the house. In this photo the roof and gable walls of the upper floor appear to be clad in a light-coloured wood shingle. The darker band between the shingled upper walls and the stone clad main wall appears to be horizontally oriented and similar in effect to the bark covered log plank sections applied to the exterior wall that are extant today. The two large, stone chimneys and the smaller stone chimney over the kitchen are seen in this image as well as a corner of the flat roofed conservatory.

Figure 12 - Riverholme, 1932. York University Libraries, Clara Thomas Archives & Special Collections, David Coombs fonds (F169)1999-064/001 (03)

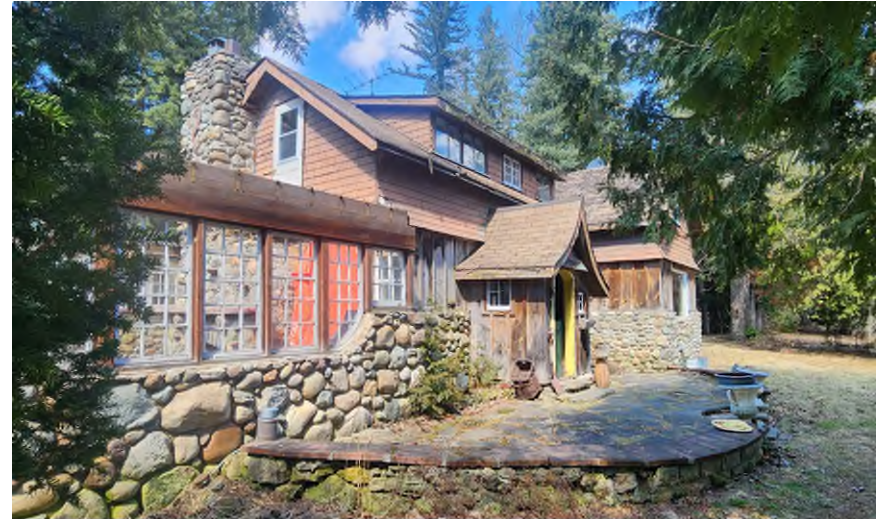
Figure 14 - Front of house from south. (Photo: RHC 2024)

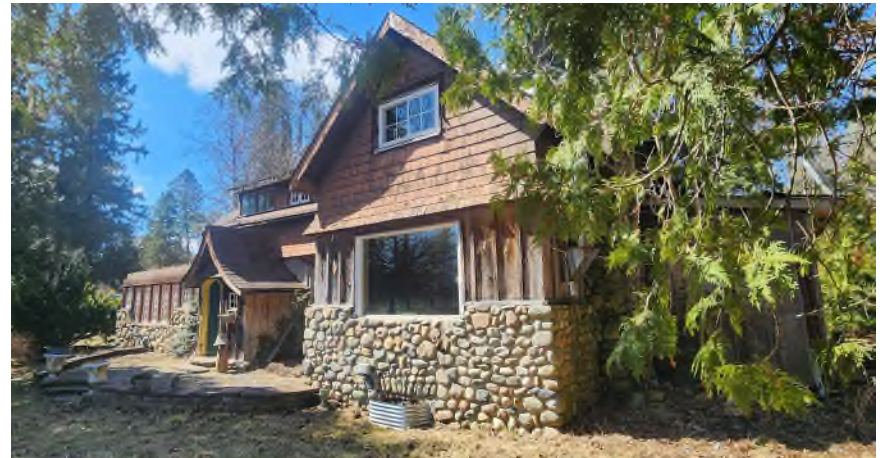
Figure 15 - Front gable from east. (Photo: RHC 2024)

The form and massing of the 1933 house involves a 1.5-storey house that faces the Credit River and a single-storey, flat roof sunroom/conservatory facing the driveway and road. The house is an irregular shape that draws from the English/Storybook cottage with both Tudor Revival and early Craftsman inspiration all of which were gaining popularity in the 1920's though to the 1940's . The additions from the 1930's resulted in a larger dwelling of irregular shape with river stone cladding on the lower third of the elevations that ties in with the large river stone chimneys and stone flat roofed stone conservatory that were added during the period. Square butt wood shingles of varied widths applied in straight, parallel courses appear on all elevations with the exception of the east elevation which has rough, bark-clad horizontal planks and just a double band of shingle above the main floor window. Much of the shingled area on the main floor has been overclad with fieldstone on the lower portion to the window sills and modern wood board and batten cladding over the shingles on the upper which could be removed and the shingles exposed to return to the original design. The modern wood board and batten cladding has been applied over the shingles to cover some of the original openings and appears to date from the same era as the large flat roofed addition on the north elevation. The upper area of the exterior is clad in square butt wood shingles of varied widths applied in straight, parallel courses that flare out in a belcast curve at the level of the upper floor plate.

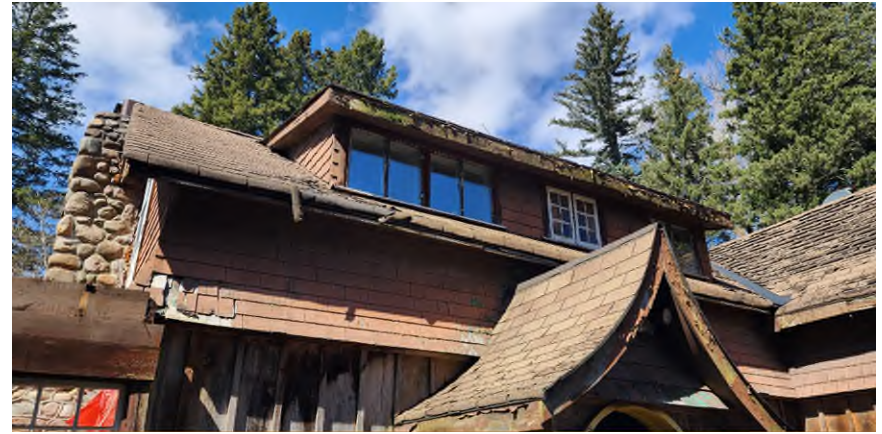
Figure 16 - Front rooflines. (Photo: RHC 2024)

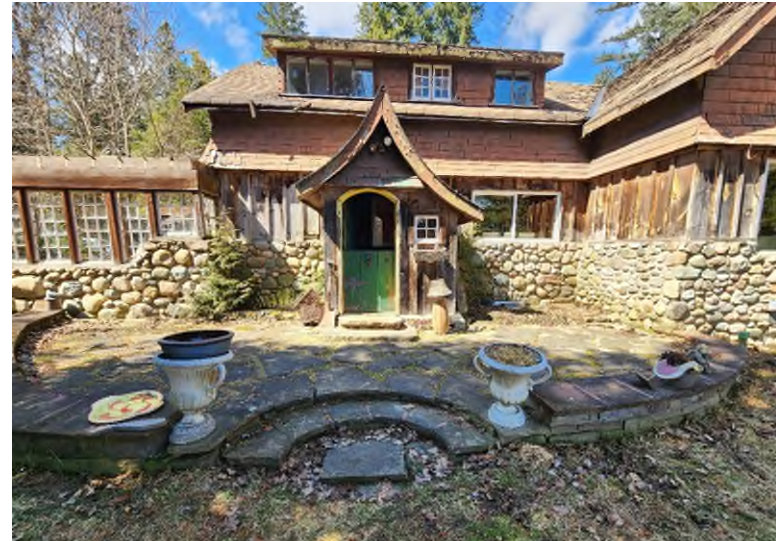
The main (side) gable walls face the road and the rear respectively and both have large, fieldstone chimneys. Both slopes of the main gable roof have wide, shed roof dormers with wood shingled walls. Only one of the original coupled, casement windows has been retained in the front dormer – all other windows have been replaced with modern single pane units. The original window sashes are stored in the basement and can be restored to their original locations or those missing can be replicated in wood matching the original individual lite, replicated muntin, stile and rails profiles in a similar wood to the originals. Coordinating wood storm windows can be created to provide energy efficiency.

Figure 18 - Front patio. (Photo: RHC 2024)

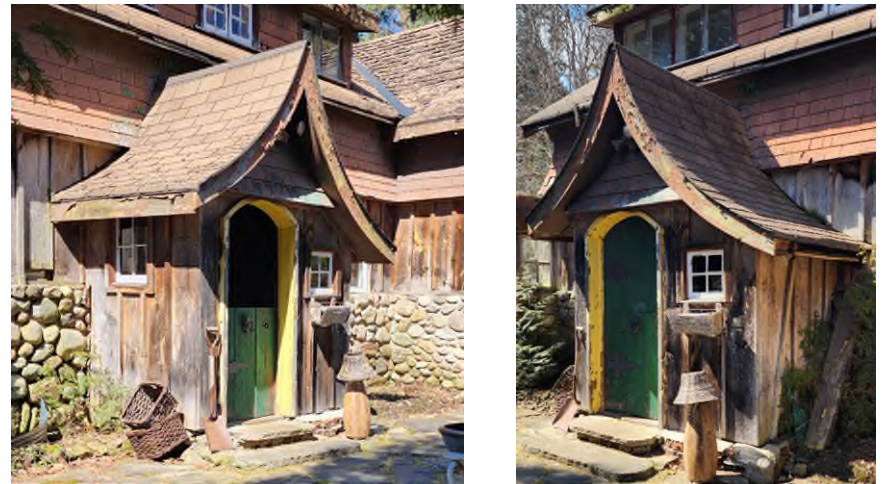
The enclosed front door porch of the house has an asymmetrical front gable roof with curved fascia boards, a belcast gable wall that flares over the exterior door. The exterior walls of the porch are clad in modern wood board and batten siding. The front porch is surrounded by a large, curving patio with a mortared flagstone floor and a low retaining wall has rubble stone and long, roughly-squared, rock-faced stones all capped with the thin, red coloured concrete slabs. The front door porch floor itself is mortared flagstone raised by two steps from the patio level. The under surface of the porch's original horizontal wood siding is visible in a small cupboard to the left of the

Figure 19 - Front vestibule. (Photo: RHC 2024)

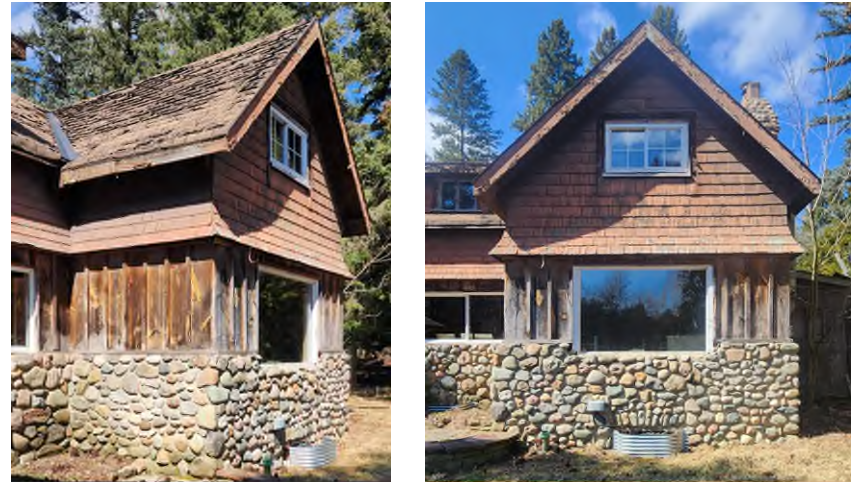
A smaller transverse gable protrudes from the right side of the façade toward the river. Both the main floor and upper floor windows have been replaced with modern units. A second fieldstone chimney rises on the east exterior wall with the main gable verge meets the eave of the south facing gable. This chimney is not quite as wide as the west chimney of the sunroom but both chimneys have a metal, S-shaped form that is likely part of a bracing rod system intended to help hold chimney and wall together due to the chimneys be added afterward rather than being constructed as part of the wall system.

Figure 21 - Front gable. (Photo: RHC 2024)

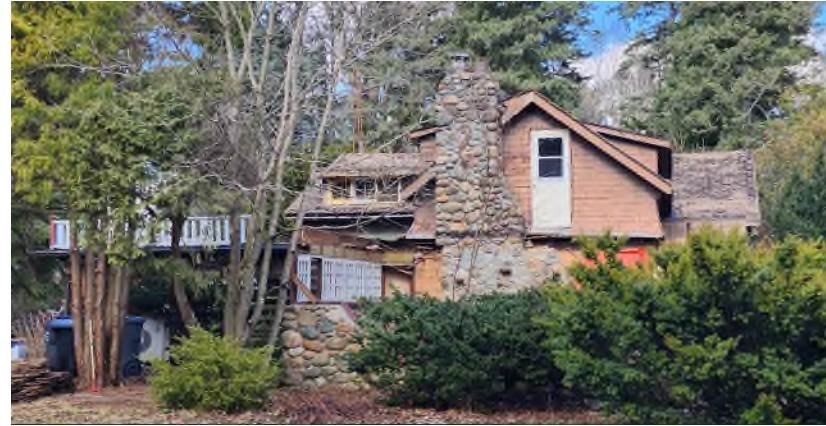
The west gable wall faces the driveway and the road. This gable wall is dominated by the large, fieldstone chimney that rises from the fireplace mantle in the sunroom. To the right of the chimney on the upper floor is a modern door that replaced a coupled window and gave modern access to the flat roof of the sunroom.

The flat roof and west window sashes and roof of the sunroom/conservatory were recently removed by the current owner. The remaining band of tall, multi-paned window sashes set in frames that rest on a round fieldstone knee wall would have originally created a continuous glazed wall on three sides of the sunroom. The top of the stone knee wall curves down in a manner corresponding to the sunken floor of the sunroom.

Figure 22 - West elevation from driveway. (Photo: RHC 2024)

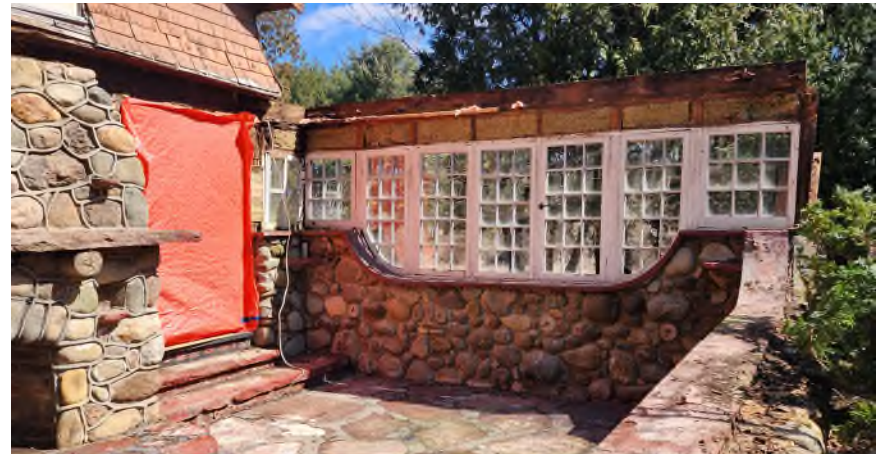
Figure 23 - Conservatory. (Photo: RHC 2024)

The only access to the sunroom/conservatory is from a 2-leaf French door in the living room leading down three stone steps to sunken floor paved with large, flat stones painted (or stained) red. The wide, stone chimney mantle beside these steps is constructed of round fieldstone of varied sizes laid in a random pattern and pointed with a raised mortar joint. The upper portion of the mantle has three small stone shelves above a long, single slab shelf of rock-faced stone which appears supported by two cut log ends with simulated end grain painted on the flat end which is also seen under the windows and may have supported something or may have been simply decorative. Below this are two small, stone niches flanking a wide segmental arch hearth opening. The hearth interior is brick and the projecting hearth floor is a semi-circle of flagstone painted (or stained) red and raised on step above the sunken floor. The fieldstone chimney above the flat roof does not have the raised pointing.

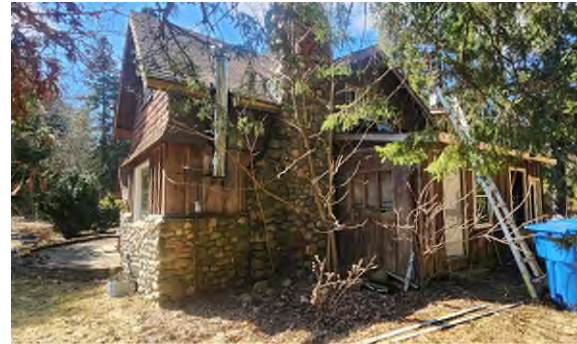
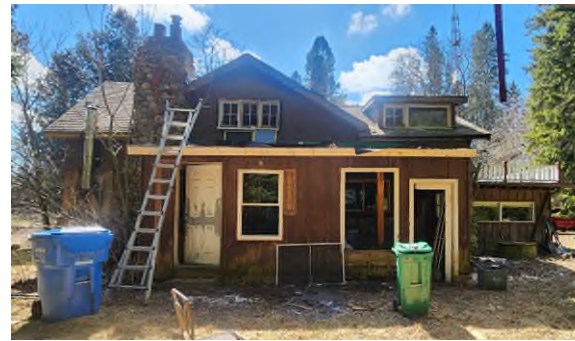
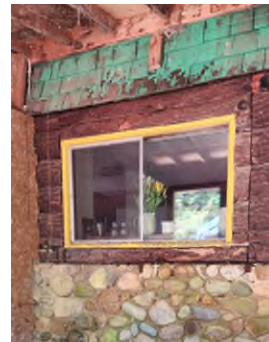
The kitchen window (seen inside the later east addition) has been replaced within what appears to be the original cladding of the exterior middle wall - rough, bark-clad horizontal planks (also seen in the 1932 photograph). Below that window is a small basement window at grade level to the right of the basement access stair. The lower stairs were constructed with stone risers and the red-coloured concrete slabs for the treads.

Figure 25 - East elevation; kitchen window. (Photo: RHC 2024)

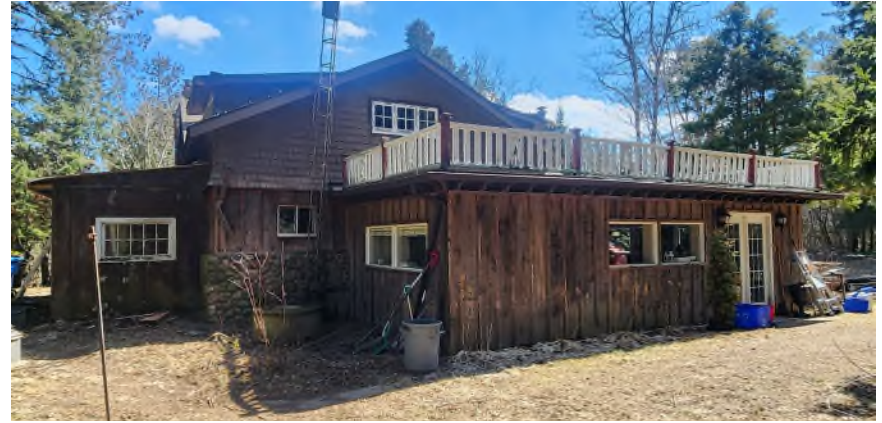
The large, lower-pitch, transverse gable that faces the north side (or rear) has its original tripled, 4-pane windows at the upper level. The centre sash is fixed and flanked by casement sashes. The shed roof dormer on the north-facing slope of the main roof has had its windows replaced and the middle section has been cut out for a door to access the flat roof north addition.

Figure 26 - North elevation. (Photo: RHC 2024)

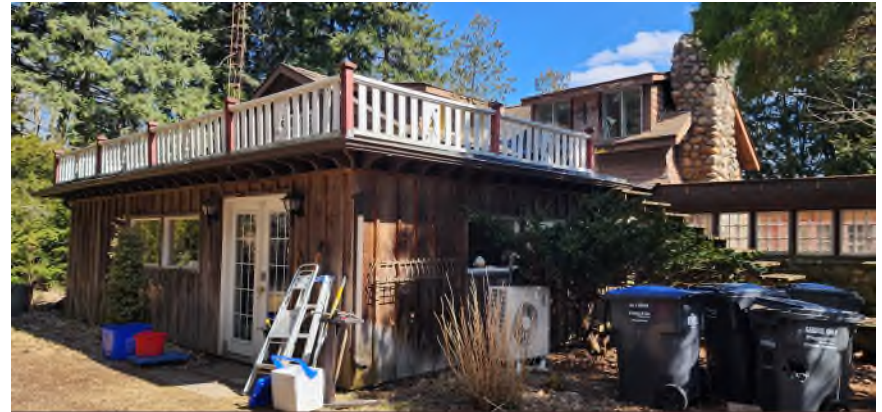
Figure 27 - North elevation with stairs to addition roof. (Photo: RHC 2024)

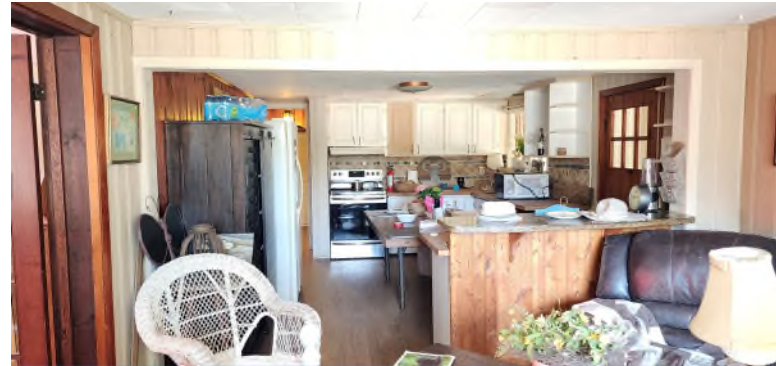
The wall between the kitchen and dining room has largely removed making one large open space combining the kitchen and dining room. The original dining room contains the granite fireplace mantle on the east wall and a picture window which has replaced the originally bank of three original sashes.

Figure 28 - View from dining room to kitchen. (Photo: RHC 2024)

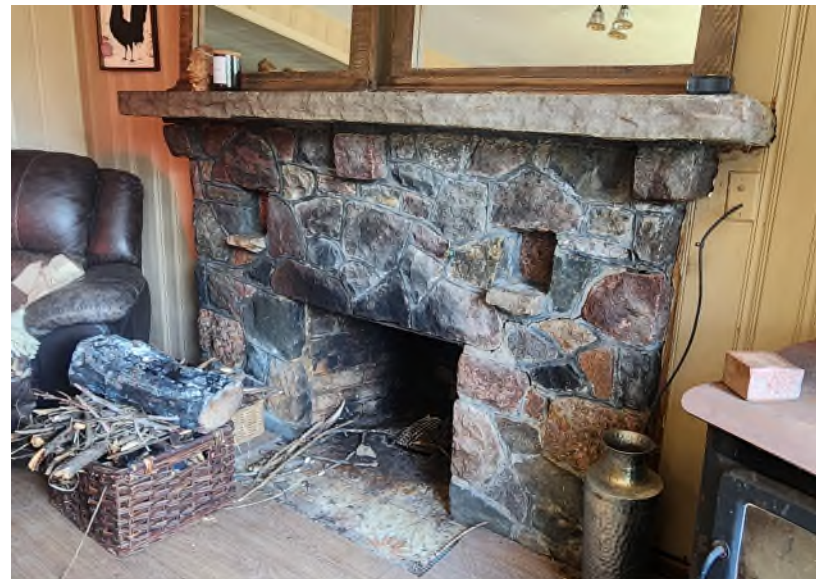
Figure 29 - Dining room fireplace. (Photo: RHC 2024)

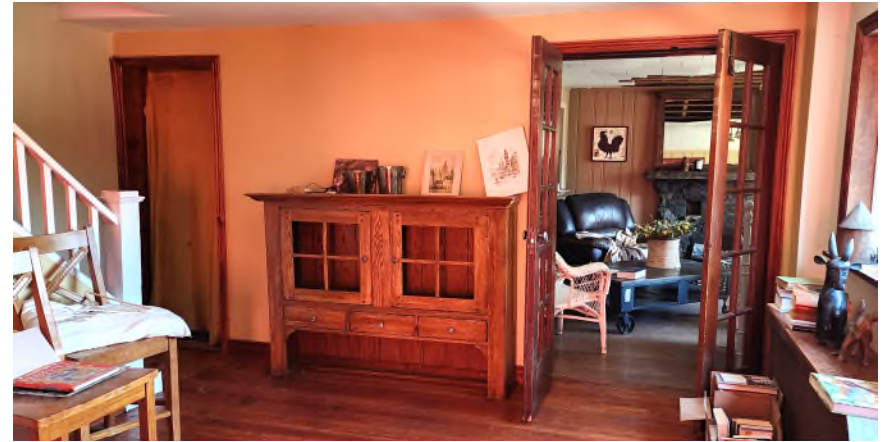
The living room has retained its original fir hardwood strip flooring as well as two sets of original two-leaf French doors that lead to the east fireplace room and to the sunporch. The finishes, handles and hardware on both doors appear to be original to the 1933 renovation. A simple staircase on the north side of the room leads to a landing and then turns to the upper floor and below it to the basement. At the foot of the stairs is a single width door leading to the kitchen. On the south (front) wall of the living room wall beside the inner front door are what appear to be three electric bells or buzzers. The function of the bells is unknown.

Figure 30 - Living room. (Photo: RHC 2024)

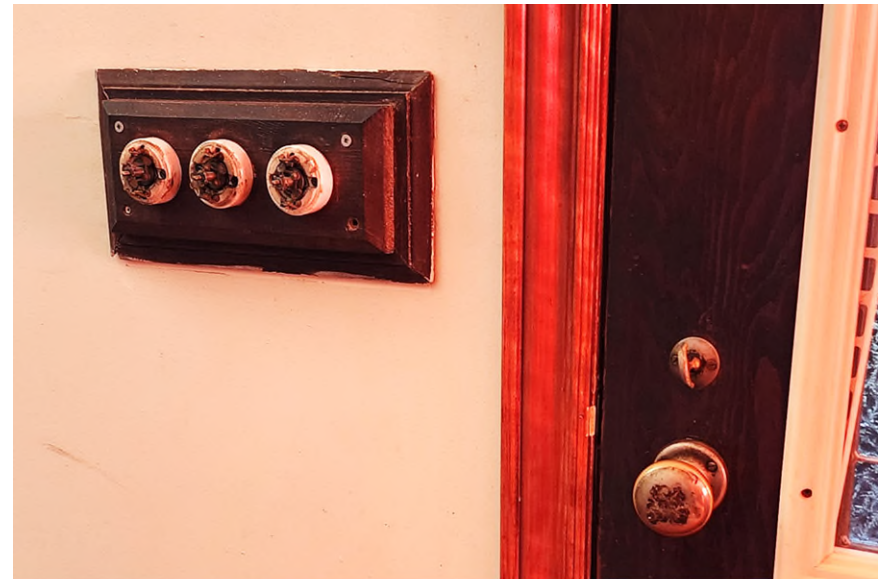
Figure 31 - Bells (buzzers) beside front door in living room. (Photo: RHC 2024)

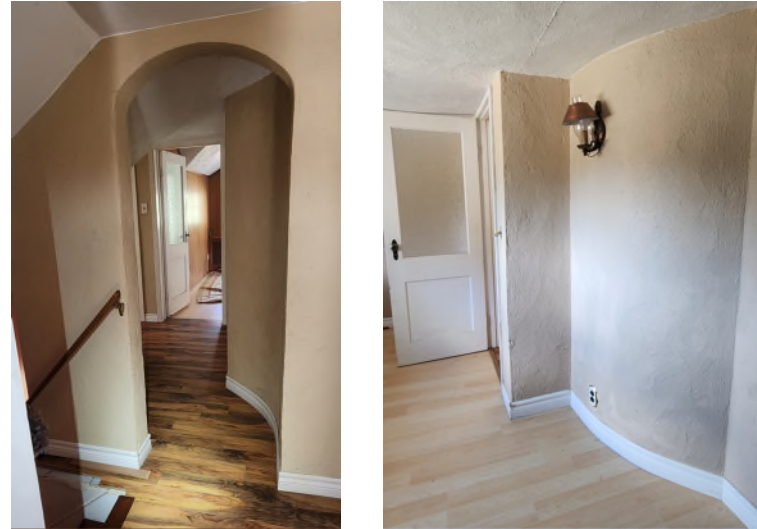
The upper floor contains four bedrooms and the washroom. All upper-level rooms have sloped ceilings and most of their original plaster and lath. All upper floor rooms have wooden panel doors that were altered to become half-glass (frosted- likely to provide light into the upper hall and stairwell). The hall in the middle of the upper floor plan has an arched doorway, the curved wall of the south bedroom and a parabolic inset in the plaster for the hall ceiling light. The east bedroom is the largest bedroom. The toilet in the washroom dates from the 1930s and is an early one-piece design known as the Case T/N kidney water closet and is a somewhat rare as an early example of a combined tank and seat. It would be lovely to incorporate in a period style modernizing of the bathroom.

Figure 32 - Upper hall and front bedroom wall. (Photo: RHC 2024)

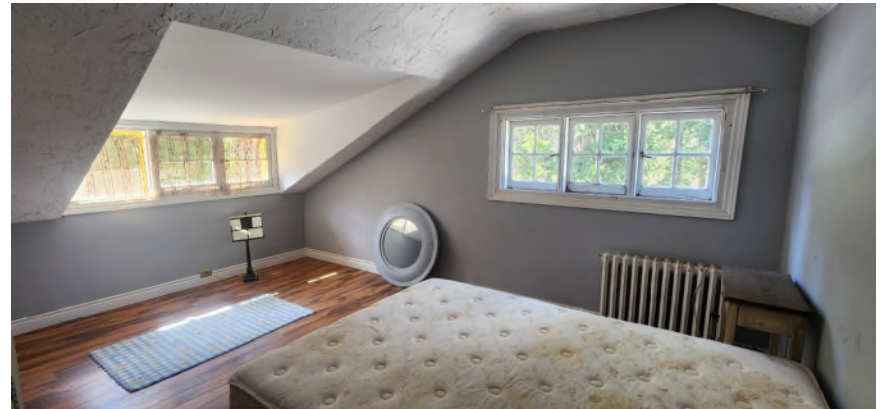
Figure 33 - North bedroom. (Photo: RHC 2024)

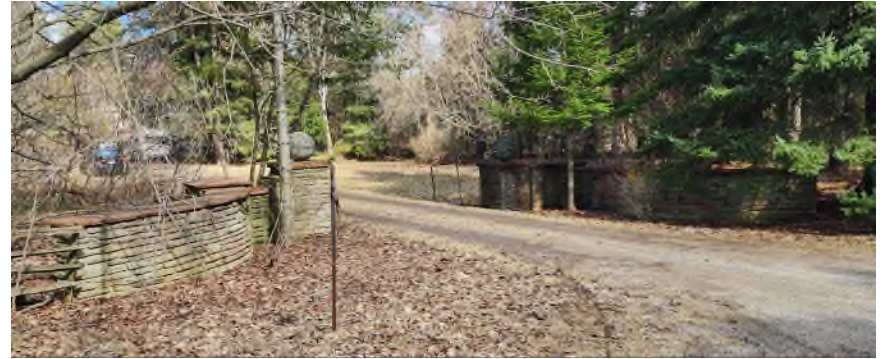
The entrance to Riverholme at Willoughby Road has two pipe and loop wire gates with wrought metal embellishment along the tops. The gates hang from walls constructed in long, rock-faced, roughly squared stones laid in even courses with a battered slope and capped with a thin, flat coping of what appears to be squares of concrete that have been painted or stained red. Both square gate posts have a single, large globe of what appears to be concrete set on top of a doubled coping. The globes have a thin render finish that is flaking off revealing a bright green paint below.

Figure 34 – Front gate from Willoughby Road. (Photo: RHC 2024)

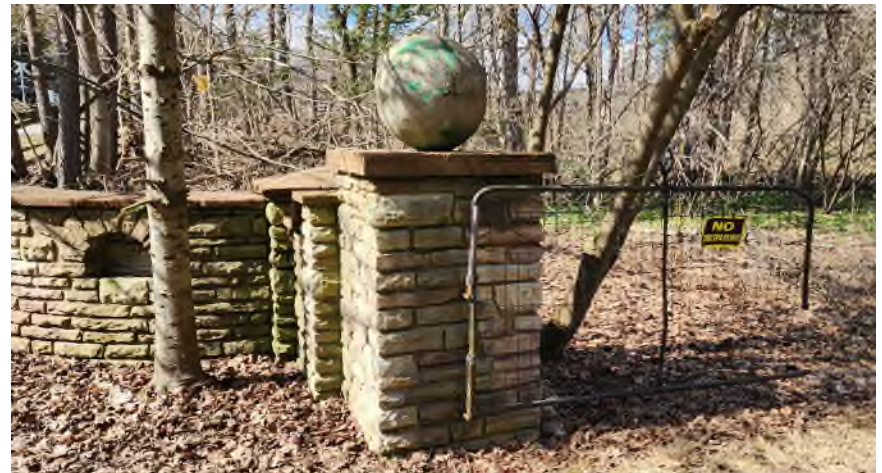
Figure 35 - Left gate post. (Photo: RHC 2024)

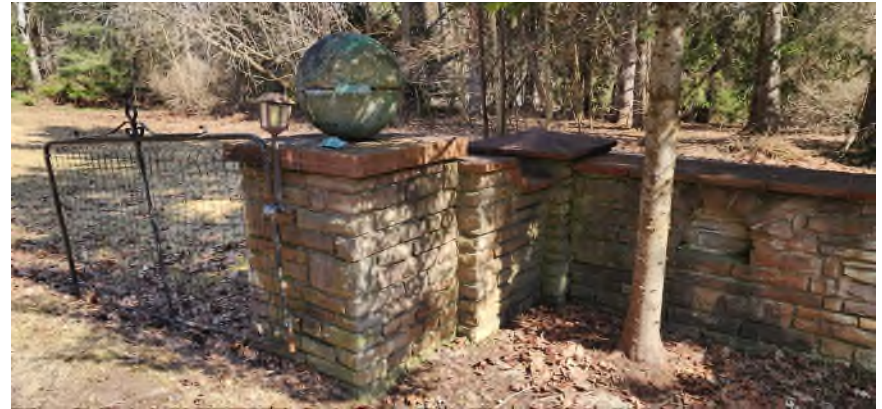
A short section of the stone wall extends from the gate post to a lower corner post with a pyramidal concrete cap created with cut and mortared pieces of the flat, red concrete. The coping of this short section transitions from the higher to the lower corner post by a curve that is similar to the curve of the sill coping of the sunroom in the house but created with narrow strips of the concrete coping. The gate wall continues as a curved wing wall ending at cedar rail fencing that is parallel to the road. Both curved wing walls contain a niche facing the entrance that has a semi-circular arch constructed with stone voussoirs.

Figure 36 - Right gate post. (Photo: RHC 2024)

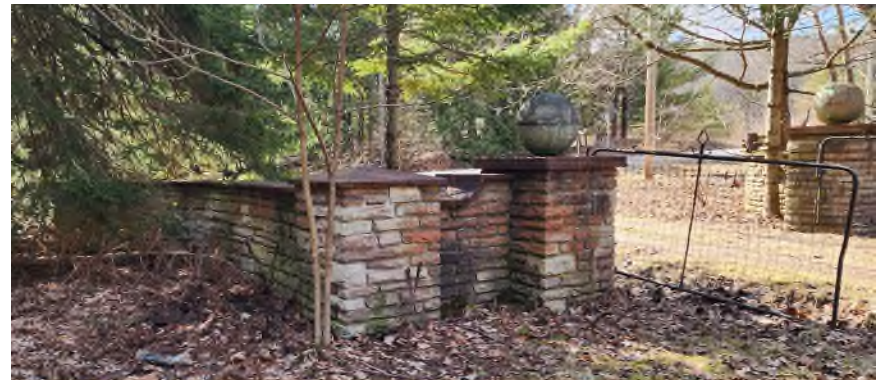
Figure 37 - Rear of right gate wall. (Photo: RHC 2024)

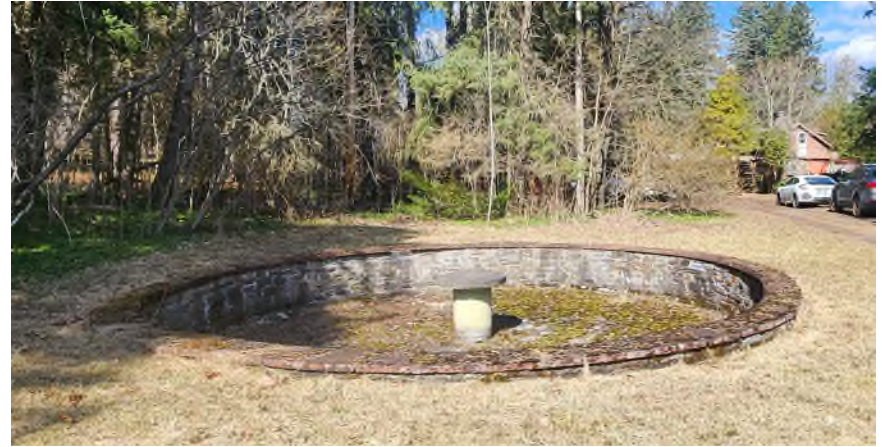
Proceeding into the property, close to the north side of the driveway is a circular, in-ground pool (currently empty of water) that is of similar construction to the gate. This pool has a circular stand in its centre. The pool walls are constructed long, rock-faced, roughly squared stones laid in even courses and capped with a thin, flat coping of what appears to be the same squares of red coloured concrete seen in the front gate. The flat bottom of the circular pool is mortared flagstone. Nearby under the trees is what appears to be a millstone laying flat on the ground.

Figure 38 - Circular pool from south. (Photo: RHC 2024)

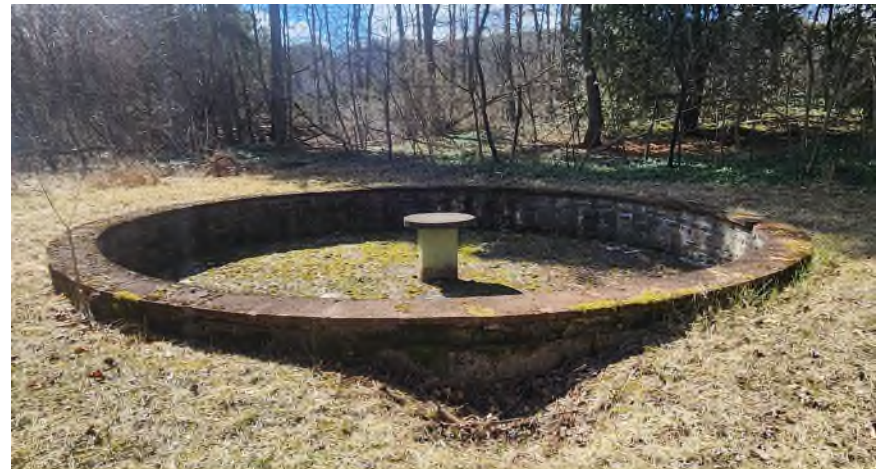
Figure 39 - Circular pool from east. (Photo: RHC 2024)

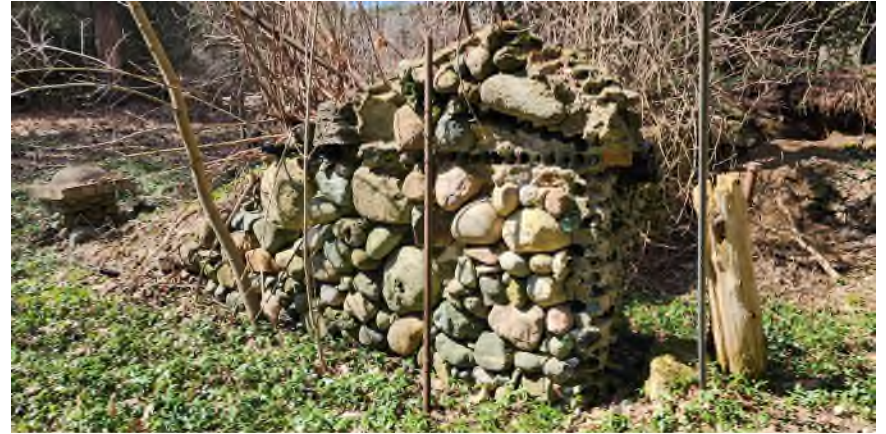
Figure 40 - Stone and bottle remnant. (Photo: RHC 2024)

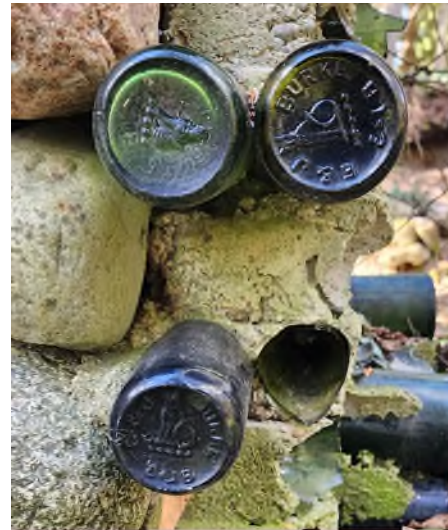
Figure 41 - Bottle ends. (Photo: RHC 2024)

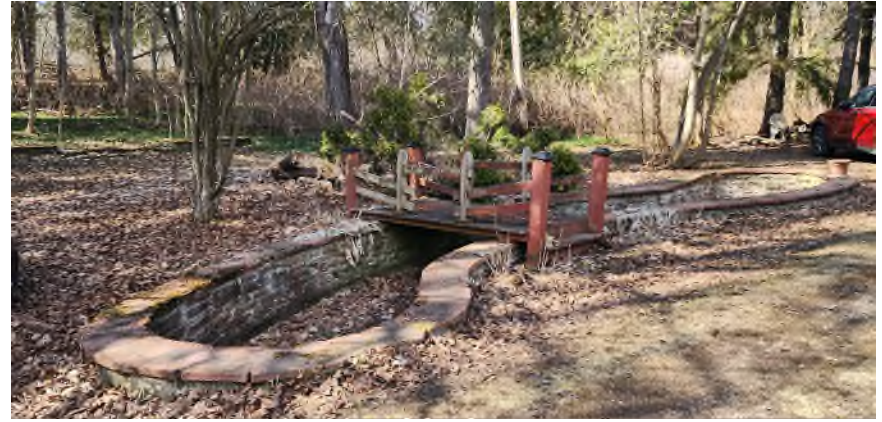
The curved, in-ground pool (currently empty of water) between the stage and the house also has walls constructed long, rock-faced, roughly squared stones laid in even courses and capped with a thin, flat coping of what appears to be the same squares of red coloured concrete seen in the front gate, the circular pool and the stage. The flat bottom of the curved pool is mortared flagstone. A design of the wooden footbridge crossing this pool is unusual with the guard rails angled down from the corner posts to the centre railing.

Figure 42 - Curved pool from driveway. (Photo: RHC 2024)

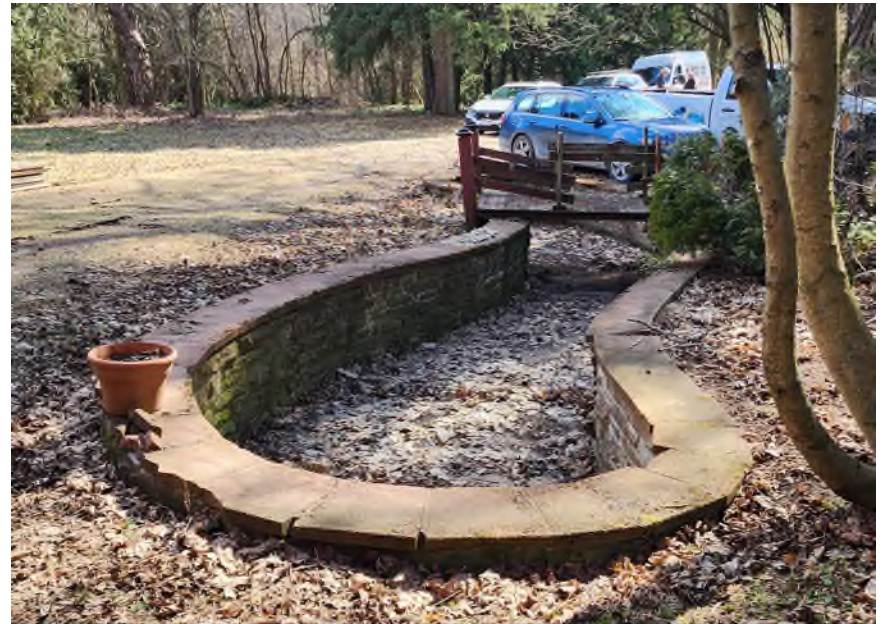
Figure 43 - Curved pool from north. (Photo: RHC 2024)

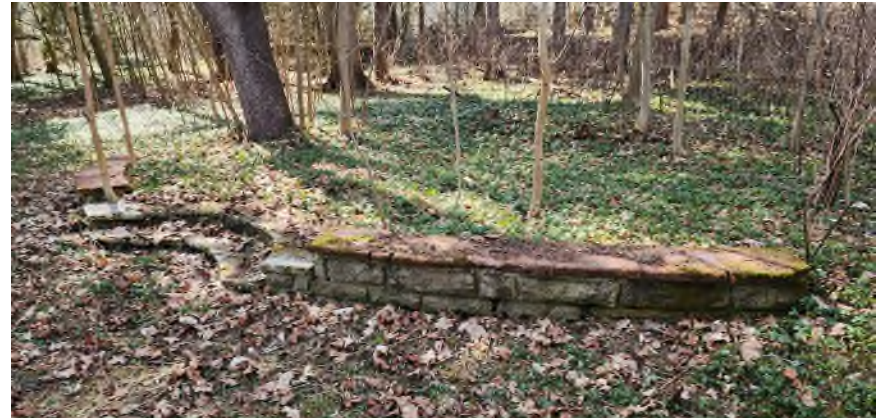
Further north from the shed is a structure that may well have been intended as a stage or platform. The coursed stone with concrete coping construction method of the front gate and ponds and the form of the front patio are seen in the low, semi-circular retaining wall with two inward curving front steps.

Figure 44 - Stage wall from east. (Photo: RHC 2024)

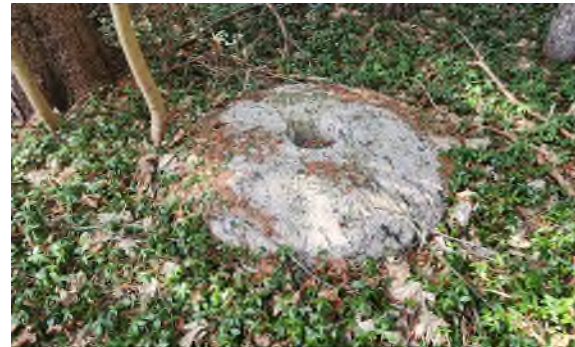
Figure 45 - Millstone found near circular pool. (Photo: RHC 2024)

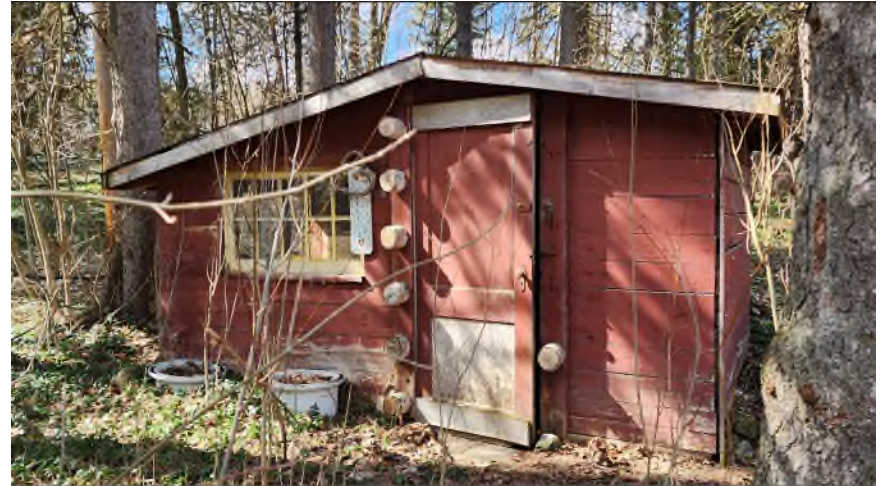
Figure 46 – Shed from driveway. (Photo: RHC 2024)

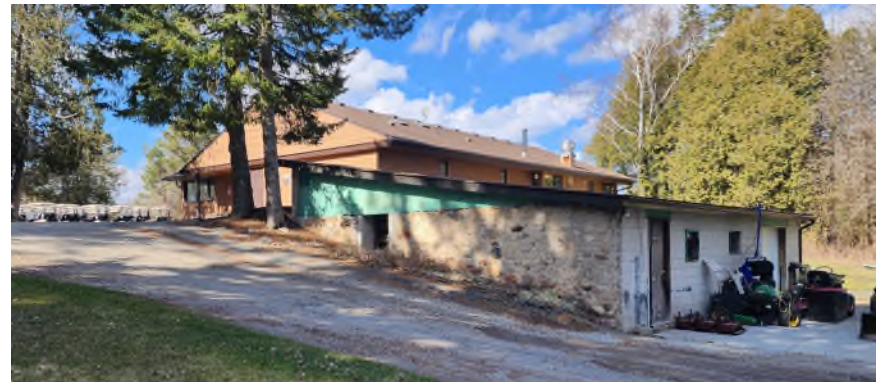
Figure 47 - Barn foundation beside modern golf clubhouse. (Photo: RHC 2024)
